FIRST ALERT

Date: 18 July 2014

Haywards - Live control cable, arc-over

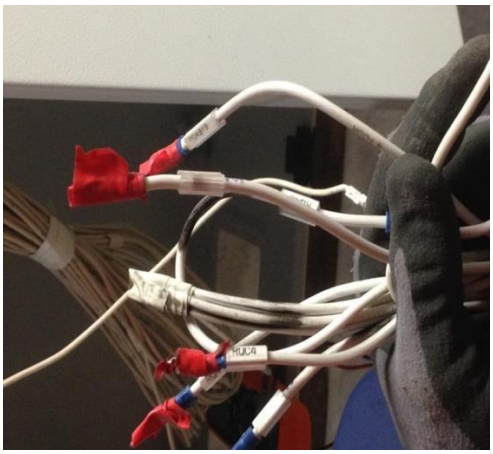
During the re wiring of a marshalling cabinet, an arc-over occurred when cable cores were being fed through a cable gland. The cable was considered to be isolated prior to the work being carried out.

Cable cores were found to be 'live'. *They were not tested before work was started.*

- Work stopped while an investigation is being carried out
- Cable isolations rechecked and made safe
