Quality Alert

**Event Number:** 16206
Event Date: 07/06/2016

Fibre block's missing

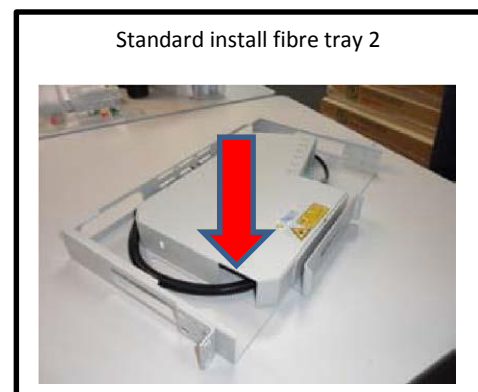
Standard install fibre tray 1

Description of Event: On the 07/6/2016, BAL T2 controller went offline. Service Provider found the fibre cores in the T2 cabinet had been chewed through causing the controller to stop communicating with the SMS. The fibre tray was installed as part of the BAL 110kV Bus Zone / SMS Installation Project, and the rodent proofing blocks were on back order. This delay in installation allowed the mice to enter the fibre tray.

Contributing Factors: Fibre blocks missing from fibre trays.

- Ensure all fibre trays have rodent blocks installed to prevent mice from getting in.
- Add a quality check specifying rodent blocks installed to all fibre work.
- Remind all maintenance staff doing sub checks to check for rodent activity especially post project or where rodent proofing has been disturbed.

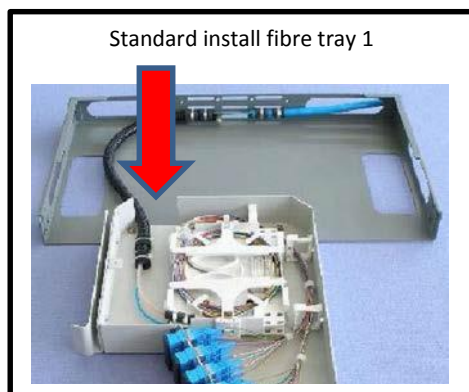
Standard install fibre tray 2

Fibre tray Rodent block installed
