TRANSPOWER

SAFETY ALERT!

28/09/2017
Maximo REF No. 101480

Insufficient vehicle access clearance in substation.

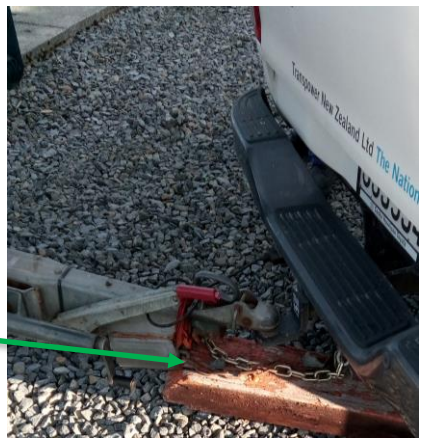
Due to insufficient clearance between the cherry picker and the vehicle rated duct covers, the front of the cherry picker connected with the raised section of the wooden duct and ripped it off.

Damaged vehicle crossing

Duct section removed by cherry picker

- Clearance of the 4WD Ute's tow hitch was low (detachable type).
- Vehicle crossing gravel was low leading into the vehicle crossing.
- Raised wooden section of the vehicle crossing is higher than the surrounding gravel.

- Spotters stopped the driver and the duct lid was retrieved and re installed over the duct.
- Informed management of the incident and a permanent repair was made to the vehicle crossing.
