# Safety Restriction

# Failure of Arteche CH-123 110 kV CT

Issuing Authority:	Network Assets
Content Owner:	Crowley. Bryan (ESB Networks)
Document Number:	DOC-040821-GXO

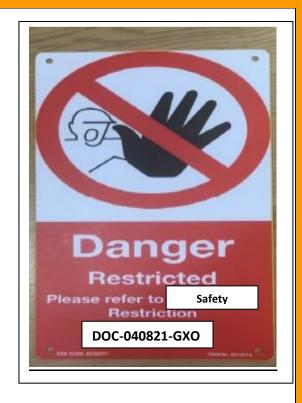
All cubicles with Arteche CH-123 CT's shall have a red restriction notice affixed (Code 8238371) to the cubicle. This notice shall be amended to include the word "Safety" in place of "Operations" and the number "DOC-040821-GXO". entrance gate to the inner compound.
