# Developing Secondary System Upgrades

A Case Study of the Waitaki 110V DC Distribution Upgrade

Prepared by William Thomas

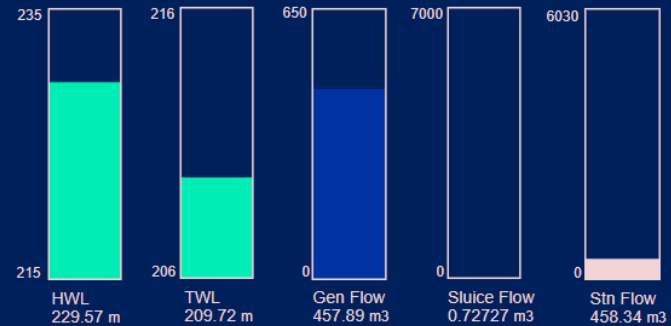
### Hydro Levels
