## Risk of Electric shock from Temporary Power Supply

As part of final work activities at the Wilton Substation, it was observed that a power extension lead was routed under the door and extended beyond the controlled area, through the fence line, beyond the earthgrid, where the work area was set-up. The following hazards were identified:

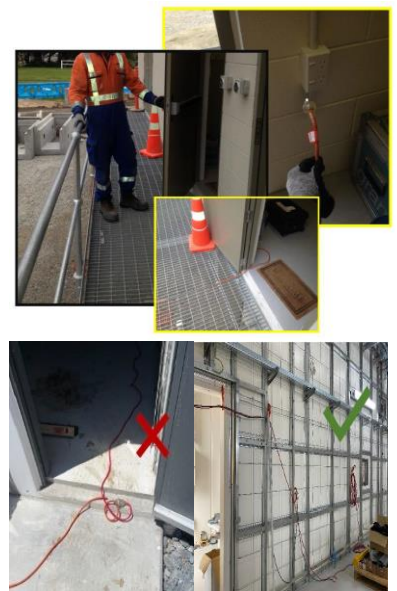
1. **Wilton Substation, 03 December 2013:** A worker suffered an electric shock after an extension lead (not RCD protected) was routed through a doorway. As the door was closed at the end of the day, it crushed the lead, damaging the insulation. This caused the metal door to become live. The worker, holding the door and an earthed handrail, became the fault path, where electricity passed through his body sticking the workers hand to the rail and in an attempt to release the arm, the worker suffered a dislocated shoulder.
2. **Hamilton Substation, 31 January 2023:** An extension lead was observed passing through an open doorway. This posed a trip risk to personnel and had the potential to cause damage to the extension lead and could result in exposed live internal wiring, exposing personnel to the possibility of an electric shock.
