# SHE ALERT

## Injured Arm

Date of incident	7 <sup>th</sup> June 2025		Directorate	Operations SEPD	
Region	South East	Location	Sandown, IOW	Classification	LTI

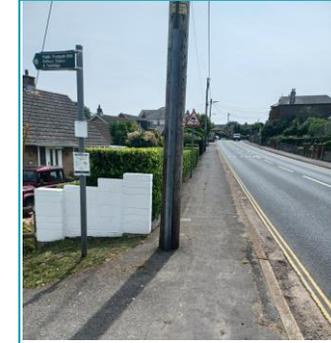
Did you review the Stage 1 Risk Assessment? Follow Rules		Yes	No	N/A
Stage 2 Risk Assessment - Site Specific Hazards and Controls - <i>not involved</i>				<i>not involved in Stage 1 Risk Assessment</i>
Hazards	Controls			
<i>Live LV</i>	<i>Control procedures</i>			
<i>Traffic (cars &amp; vans)</i>	<i>fall off load if possible</i>			
<i>Night time</i>	<i>barriers etc</i>			
<i>Working at height</i>	<i>Control procedures, pole checks, use splices as ladder position not great.</i>			
<i>Falling objects</i>	<i>Normal exclusion zone</i>
