# Life On-Line:

Lichen Growth and its Impact on Insulators

James Bai

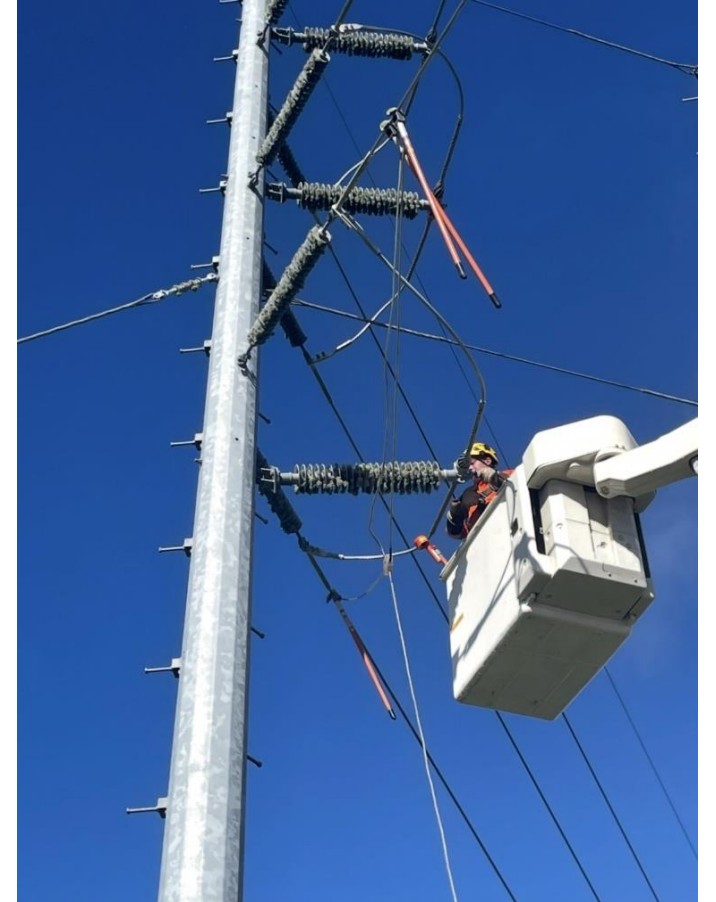
# Visual Observations

- Continuous biological growth observed along entire Silicone body
- No trace of degradation, erosion, electrical activity, or debonding of the Silicone
