Update on Asbestos in Operational Premises

1. LV Distribution Boards clad with asbestos containing materials (ACMs)

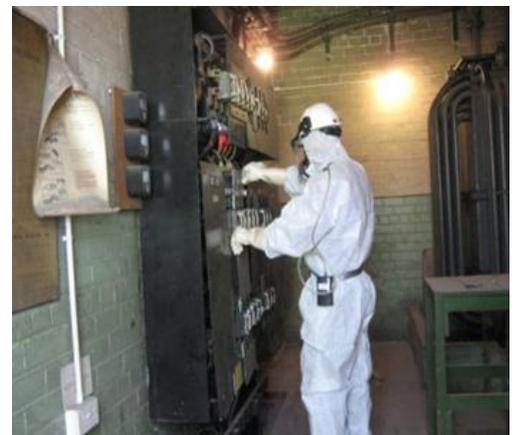
As operational staff in South Yorkshire will know we have a number of LV distribution boards clad with an asbestos composite material (ACMs). Many of these ACMs have been damaged in the past, through removal and LV fuse replacement, and airborne asbestos fibres are likely to have been produced. We have subsequently carried out air test whilst staff have been operating on these LV distribution boards and have found that any fibre release is well below any control limits specified in The Control of Asbestos Regulations 2012.

However, it is company policy that those who operate, i.e. remove/replace fuses, fit generators and test, on such boards are fully trained in non-licensed asbestos work and wear appropriate PPE and RPE. **Asbestos awareness training is not sufficient to operate on these boards.**
