BIDOYNG SAFETY CHECKS

Updated for clarification, Safety Bulletin B237 Issue 01 has been withdrawn.

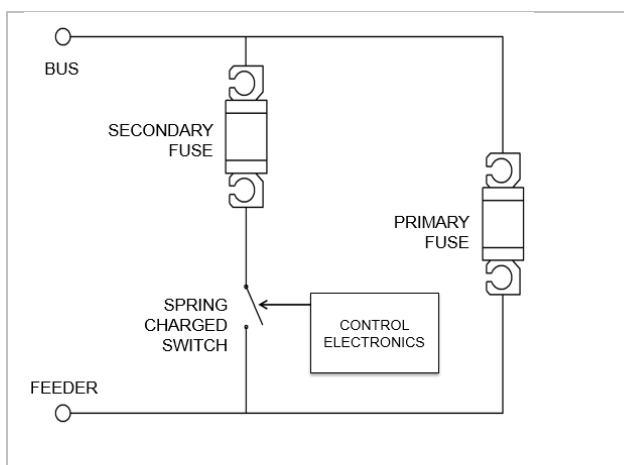
Figure 1a. Bidoyng circuit diagram in normal operation (at initial installation)

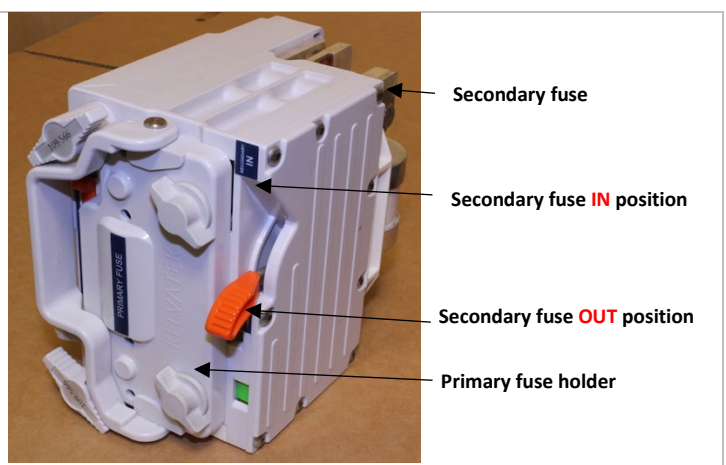
Figure 1b. Bidoyng unit (white)
Please note that the white Bidoyng shown above is for illustration purposes only. Only the black Bidoyngs, which have a higher thermal rating, are in use in UK Power Networks.
