Technical Alert

ABB 50kVA Transformer MV Termination Eye Bolts

| Document Number: | DOC-140720-FVB |

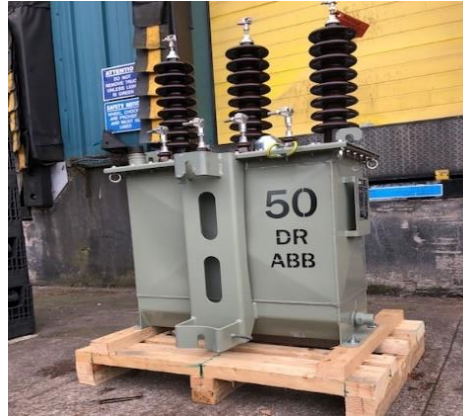
Figure 1: ABB 50kVA Transformer

ESB Networks has recently received delivery of 96 new ABB 50kVA three phase transformers, Code 3633614.

An issue has been identified which concerns the MV termination eyebolts used on the ABB 50kVA transformers. The MV eyebolt is fracturing with minimum tightening force applied, when terminating conductor in the eyebolt as per Figures 2 and 3 below.

- All new ABB 50kVA transformers currently stored in ESB Ballycoolin have been quarantined until corrective measures have been put in place.
- All new ABB 50kVA transformers in local depots should not be installed until this issue has been addressed and corrective measures can be put in place.
- Depots that have ABB 50kVA transformers in stock should contact Ciarán McBrien Network Assets OHL, Ciaran.mcbrien@esb.ie 087 410 2720, to highlight how many units they have in the depot to allow for replacement parts to be despatched when available.
