SAFETY ALERT A135

UK Power Networks
Delivering your electricity

MR TAP CHANGER LIFTING DEVICE FAILURE

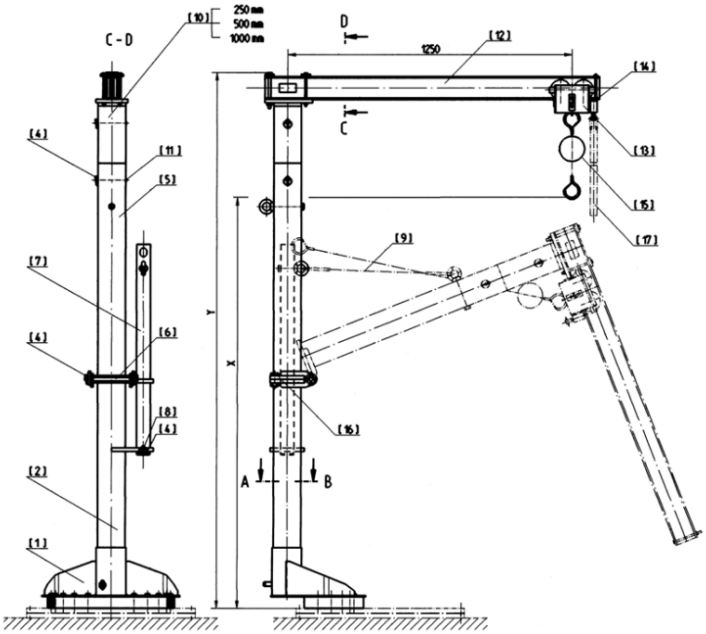
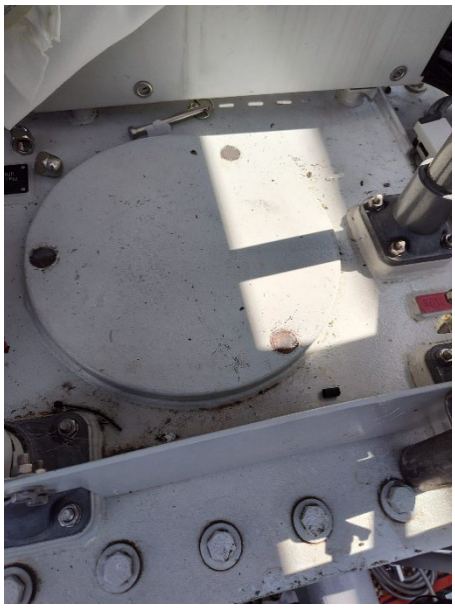
On 23rd June 2026 an MR Tap Changer lifting device was being used at Peterborough South Grid, during a tap changer inspection being carried out with a technician from the manufacturer. During use, the studs fixing the triangular foot of the lifting device to the transformer sheared off. Fitters were able to support the tap changer insert and lifting device to prevent any injuries or damage to the equipment.

Investigations are ongoing with the transformer manufacturer to determine the cause and until this is known, the use of MR Tap Changer Lifting devices is prohibited.

- Do not use any MR Tap Changer Lifting Device
- If a Tap Changer insert is to be removed, a scaffold-mounted lifting device shall be used
