# SHE BRIEF

## Chainsaw Injury

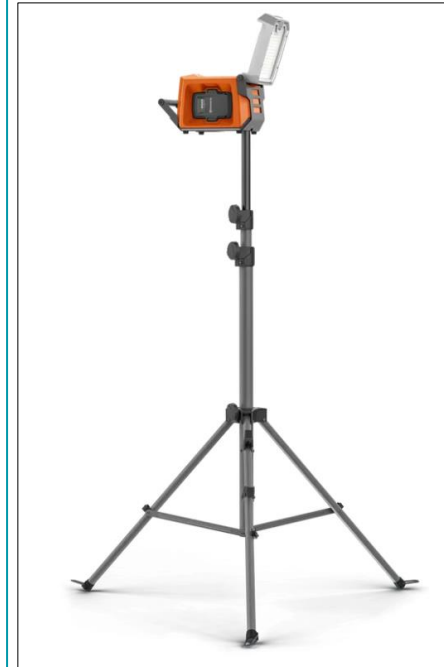
Husqvarna WL 8i Lighting System on Trial

- The tree was cut at the wrong end where there was the potential for stored energy release. With a wind-blown tree it should be cut following an assessment of the tree paying particular attention to where there is the most compression and tension.
- The response to the incident (emergency response plan) and first aid given on site was exemplary. It was escalated and reported as per procedure.
- It was identified during the investigation that inadequate lighting was a contributing factor to the incident occurring. Improved lighting conditions would have led to a better assessment of the tension on the wind-blown tree. We are currently looking into lighting options with two lighting systems on trial.

- We will continue the trial on the new lighting system and report the feedback in the close out brief.

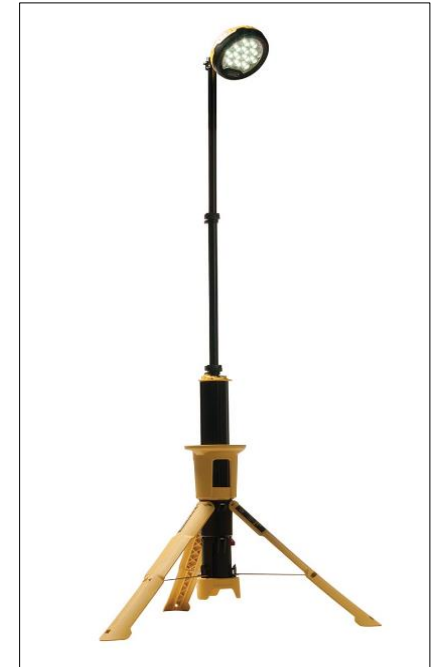
Peli Remote Area Light on Trial
