**AUTUMN 2012 ENA
SHE MANAGERS
REVIEW OF PAST ASSET
RELATED INCIDENTS**

SHE REVIEW – AUTUMN 2012

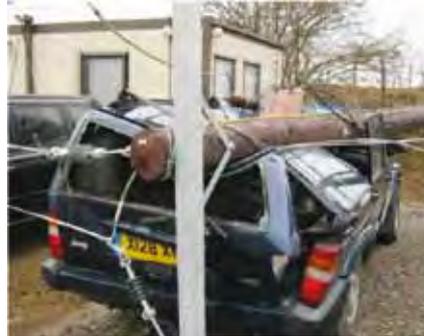
POLE FALLS INTO CAR PARK

In one incident an 11kV terminal pole with a pole transformer mounted on it fell into a car park damaging eight vehicles and writing one of them off.

The direct cause of the collapse was found to be that the pole had not been installed to the correct depth.

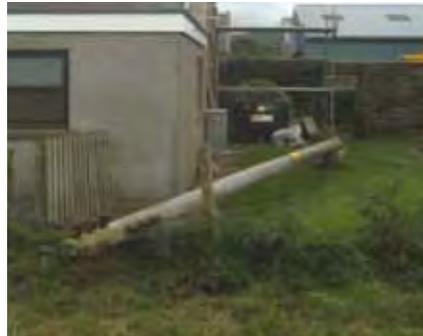
DECAYED POLES

There have been a number of incidents where linesmen have climbed decayed poles which have then fallen while the linesmen were on the pole. Some of these have resulted in serious injuries or fatalities, both to linesmen on the poles and to others who have been hit by the falling poles.

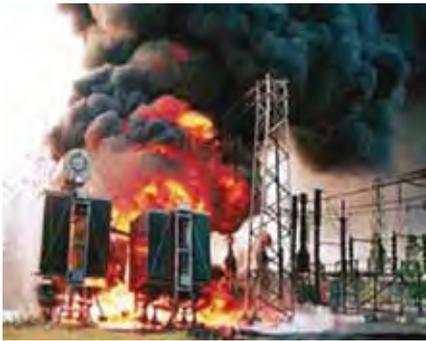
A fatal incident occurred when an engineer tried to manually operate a high voltage tap changer and the unit exploded, killing the engineer.

The direct cause of the incident was the failure of the mechanism in the tap changer leading to an electrical fault which caused the oil in the unit to ignite and explode.

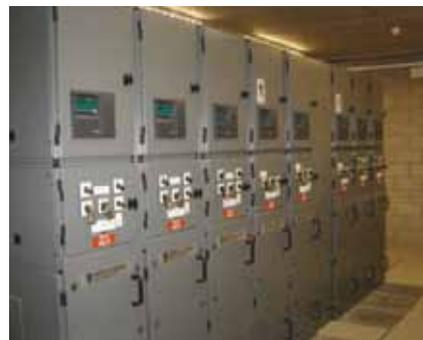
In a similar incident involving 33kV switchgear, a test lead was left on cable terminations and subsequently the covers were replaced with the test lead still connected, resulting in an explosion and extensive damage when the circuit was re-energised. No one was injured in this case.

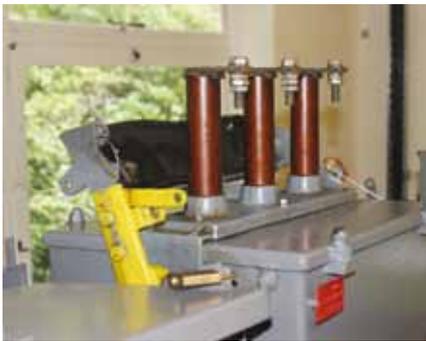
These incidents can be very severe because the insulating oil can be ignited by any flashover, leading to a fireball. These prods are designed to be used safely in tanks which may have live conductors in them. They rely on a correct fit to guide them, so correct use of the right prods, in good condition, is critical.

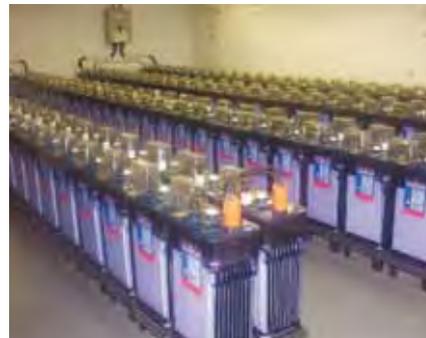
All the cells from a number of primary substation batteries were stolen, but this was not noticed immediately because the battery charger was connected across the battery terminals.

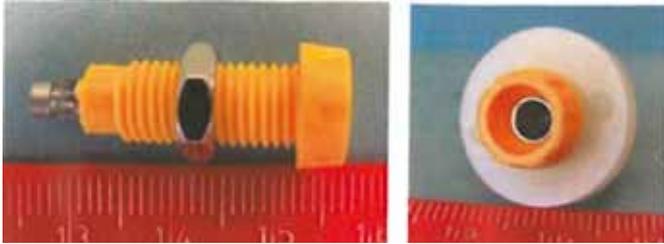
A flashover occurred and the engineer received burns to his hands. It is believed that the insulated body of the test socket failed and the conducting part of the broken socket made contact with the earthed metal of the LV Board.

Other incidents had also involved test leads with terminations that were not 4mm plugs being forced into the sockets.

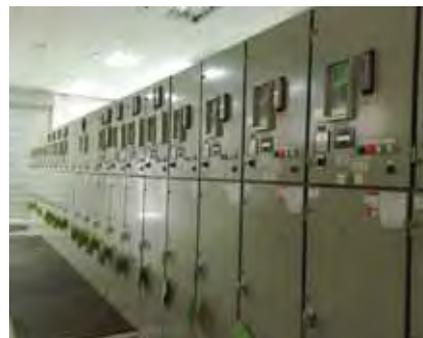
A voltage transformer (VT) failed catastrophically. The porcelain bushing exploded resulting in fire and ejection of debris over a 30-metre radius. This resulted in severe damage to an adjacent circuit breaker, current transformers, busbar supports and disconnecting equipment within the associated equipment bay.

The subsequent investigation determined that the catastrophic failure had been caused by a flashover in the condenser core of the voltage transformer, due to moisture ingress. This failure mode was a known failure mode, and this particular voltage transformer had exhibited high readings during previous loss angle tests. These tests were not followed up on.
