SHE ALERT LV Cable Flashover

Date of incident which is raised in days	07/05/2024		Directorate	SEPD	
Region	Wessex	Location	Salisbury	Classification	PTBW
What happened ?

SHE BRIEF LV Cable Flashover

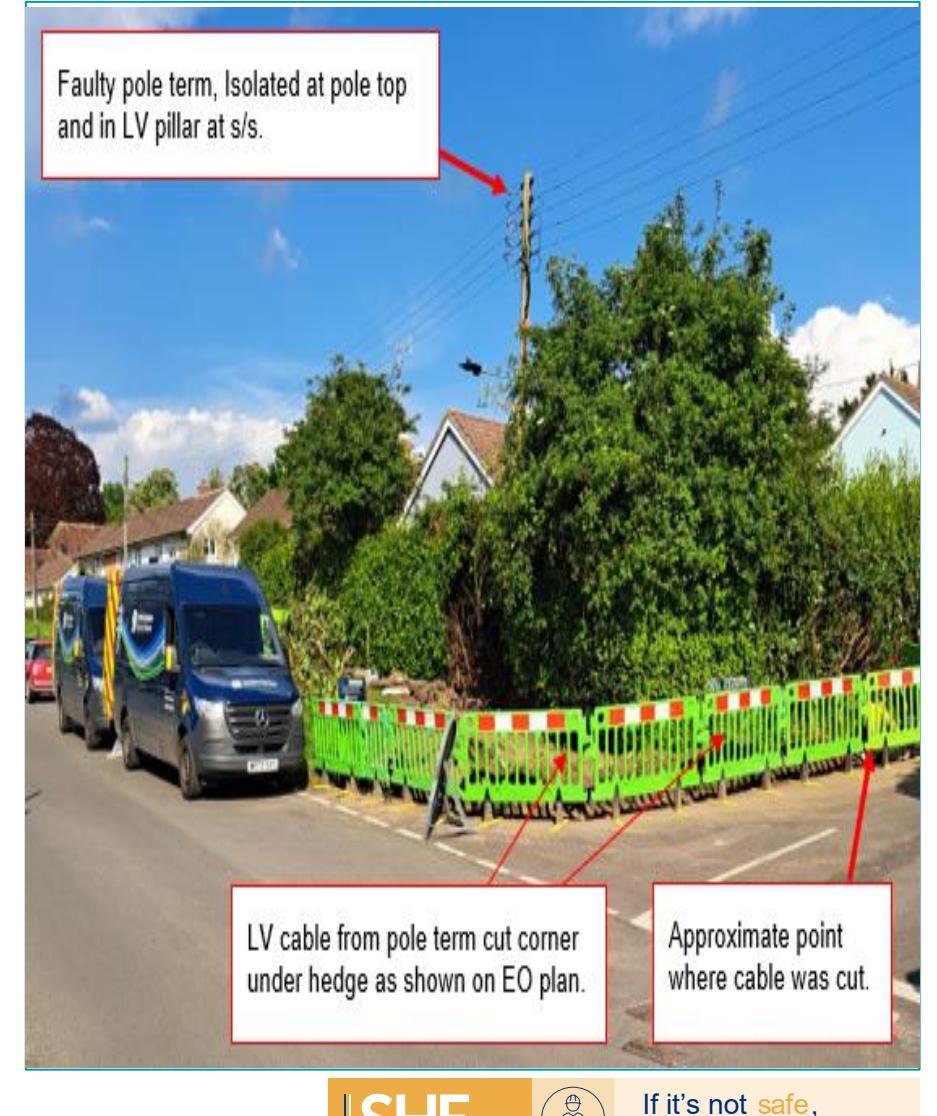
A faults team had isolated a section of network in order to replace a faulty pole box. The cable jointer had opened the cable at the bottom of the pole but found that it was too wet to joint, the cable then ran underneath a hedgerow, so the team excavated on the other side of the hedgerow and found a cable. The assumption was made that it was the same cable and the jointer then cut into a live Low Voltage main with a reciprocating saw. The street lighting core of the cable was damaged, resulting in rupture of the controlling fuse.

- If there is a change to your planned task, make sure that you revisit your Risk Assessment and highlight any new potential risks.
- Unless you can physically trace a cable from a point of isolation where it has been proven dead, live working techniques shall always be employed.

- Reciprocating saws should only ever be used in the case of the above statement or on LV cables that have never been connected to the network or for dead HV working.

- Always check your drawings to fully understand what cables or other utilities are in the ground and where they are. All cables in the vicinity need to be exposed to correctly identify the cable to be worked on.
