HSE ALERT

RMSS# 15086

Wheel Failure on Tandom Tralier

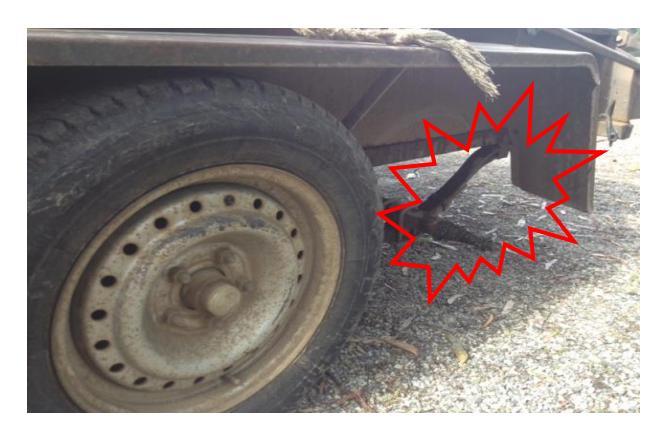
Pictures/Diagrams:

When a work crew arrive onsite at Greens Beach they noticed that one of passenger side wheels from the tandom trailer was missing. The trailer load was 670kg's and within the towing capacity of the trailer, which had been recently serviced on the 25th of August. The crew had completed a pre-use check prior to departure and did not notice any issues during the inspection. It appears the wheel must have rolled off the side of the road without incident but obviously there was potential for a serious outcome.

All trailers in the depots are to be checked by rocking each indivual wheel from side to side. If there is any movement (slack) do not operate the trailer until it has been checked by a mechanic. Each depot is to report their findings to their regional manager including number of trailers and confirmation all trailers were checked.

Until further notice all pre-start checks on trailers to include wheel and hub integrity by following the afore mentioned process (above). This should also include a check for loose wheel nuts.

The maintenance service provider will be engaged as part of the investigation to determine maintenance proactices
