## Live Line Incident March 2010

1. Incident Outline

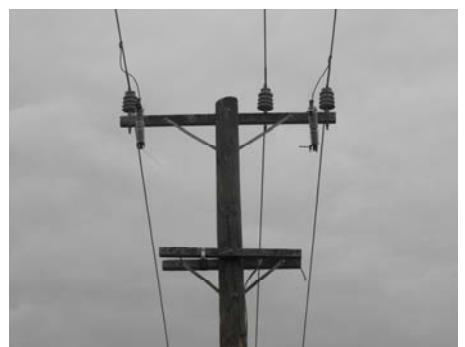
Fig 1. Fuse jumper tapping situation

A live line mechanic was in the process of making the permanent connection of one of the drop-out fuse jumpers to the main line, when the excess jumper length contacted the adjacent phase resulting in an 11,000 volt phase-to-phase flashover.

- (vi) Ensure cover-up equipment is applied to all second points of contact
  - (vii) Jumper leads must be kept to a minimum length and terminated into HV fuses using live line techniques after the pole installation

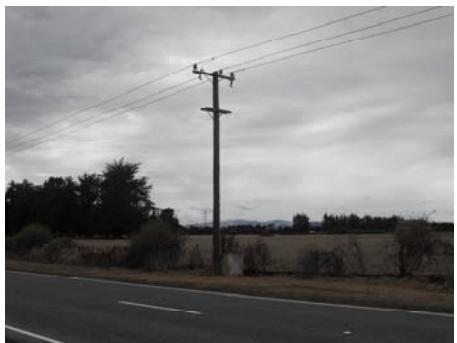
Fig 2.. Wider view of incident situation

The Glove & Barrier live line task involved in this incident was the tapping of drop-out fuse jumpers onto the 11,000 volt live over head line.
