Working on Incorrect Equipment

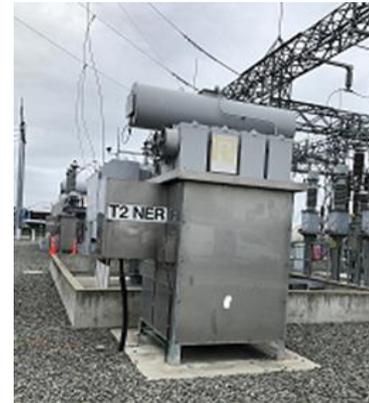
While undertaking scheduled maintenance on T1/NER1 an employee was found to have started to remove the bolts from the cover of the in service NER 2. NER 2 was not part of the work to be carried out and was not within the permitted area. The worker had wrongly identified this as the equipment requiring work.

Staff member started work prior to the daily brief and inductions being completed. Staff member incorrectly identified the assets which were being worked on.

After assessing the worker was not at risk, the worker was instructed to re-instate the bolts.

- There needs to be a process including on site assessments to deem staff competent for tasks requiring Works Management qualification.
- Staff including Supervisors have been reminded of their responsibilities and activities which need to be completed when signing onto a permit. These include, but are not limited to; identifying isolation points, earthing, nearest live points, identification of equipment being worked on.
