P&P Rope Rat

Issue date	18 April 2024
Issued by	Paul Turner, Head of Policy and Standards
Applicable to	All colleagues

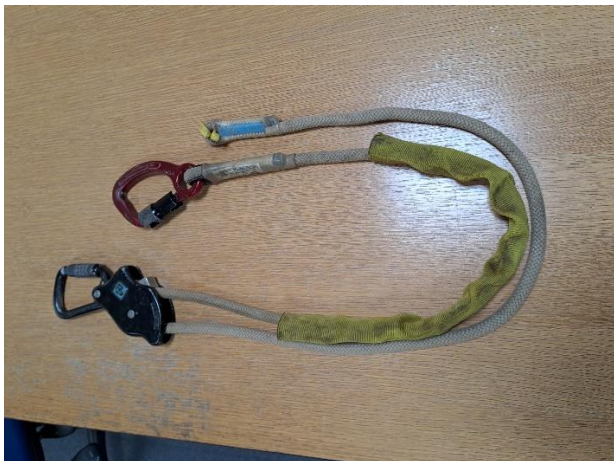
We've received two defect reports for the P&P rope rat work positioning belt.

The defects reported were for the red double lock karabiner failing to operate correctly by not locking after closing. Both rope rats have been withdrawn and returned to the supplier/manufacture for investigation.

As with all PPE, please inspect your rope rat before and after use. While you're using it please also check that the red double lock karabiner locks after closing.

If you identify an issue, stop work and remove the rope rat from use. Please refer to Code of Practice 430 part one overhead line technique 108 for inspection of PPE for more information.

If you identify any defects when inspecting a rope rat, stop using it and send it to David Talbot, Circuits Policy Manager, with a defect report so it can be investigated by the manufacturer. Please include the serial number and manufactured date in the defect report.
