SHE ALERT Contractor Reportable Injury -Crushed Hand

Date of incident	06/12/2023		Directorate	Customer Services	
Region	Large Connections	Location	Horton Heath, Southampton	Classification	Contract Partner RIDDOR

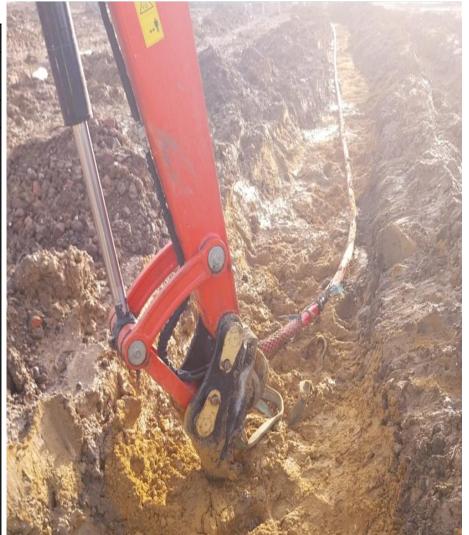
Our Framework Partner's cable gang attended a site to pull approx. 150m of HV cable. During the task, the Gang Supervisor accepted an offer to utilise the site's excavator rather than use the cable winch. During this unapproved practice, the sling caught in the excavator's lower hitch which led to the Supervisor attempting to unsnag the sling. In doing so the IP's hand was left within the line of fire so that when the excavator driver closed the hitch, the IP's hand was crushed between the hitch claws. The IP was administered pain relief by paramedics and taken to hospital where it was confirmed they had fractured four bones in their hand and underwent successful surgery that same day.

• Work to your established Safe Systems of Work and if it's not safe, use your safety licence to stop.

- Select appropriate plant and equipment that is correct for the task
- Keep yourself and others out of the line of fire
