## 400V Arc Over Event – Missing Busbar Fuse

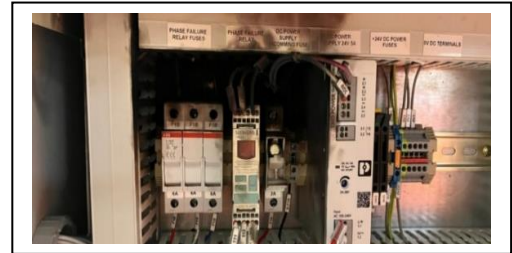
- Following commissioning of a new 400V LVAC Board the board HMI screen wasn't working which was proven to be working in pre-livening checks.
- To investigate, the control cabinet was opened and a suspect fuse was inspected which revealed a loose wire that was close to touching the earth. A MCB was switched off to isolate the loose wire.
- A test was carried out to prove that the loose wire was not live. This action dislodged the wire which happened to be not isolated and led to a phase-to-earth fault resulting in a flashover which vaporised a section of wire.
- No injuries occurred as all quality and safety procedures were followed.

*Affected controls cabinet*

- The wire was disconnected by the Switchboard Manufacturer during Factory Acceptance Tests and not securely reinstalled leading to an intermittent connection.
- A fuse was not installed by the manufacturer on a 1.5 mm<sup>2</sup> supply wire leaving it protected only by the main MCB.

- The Switchboard Manufacturer has undertaken a thorough investigation and implemented procedures to prevent future incidents like this from occurring.
- The importance of taking 5 has been re-iterated to Ventia staff

- Review circuit diagrams for any wiring that might be connected directly to the busbar and where feasible carry out visual checks to confirm that all fuses have been installed.
- Take 5 to ensure the correct isolations are taken.
