SAFETY ALERT 24/06

Chainsaw kick back.

High potential incident.

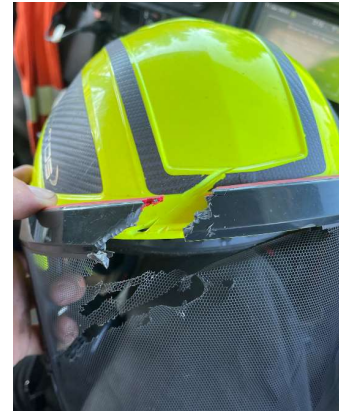
An experienced utility arborist was clearing a pile of slash in preparation for loading into the mulcher, when his saw kicked back and struck the brim and visor of his safety helmet. He was not injured.

- The saw had lost much of its sharpness and become loose due to use during the day, and the operator was having to force it to cut, rather than let the saw do the cutting.
- The position of the operator did not provide him a solid platform, and he was in line with the saw rather than offset. He was overreaching with arms bent rather than locked in, using the tip of the chainsaw to cut a small branch, and as a result, he has less control of the saw.
- This occurred near the end of the day, in hot, dry weather. Fatigue is a likely contributing factor to all the above.

- Tools and equipment are maintained and checked both before and during the work.
- You are in the best work position to safely carry out the task. If needed, reposition until you are.
- Take regular rest breaks and hydrate.
- Take 5, reassess every task for risk, no matter how routine.
- Always wear PPE appropriate for the task.
