FIRST ALERT

23 July 2025

Lines worker sustained a crushed finger injury

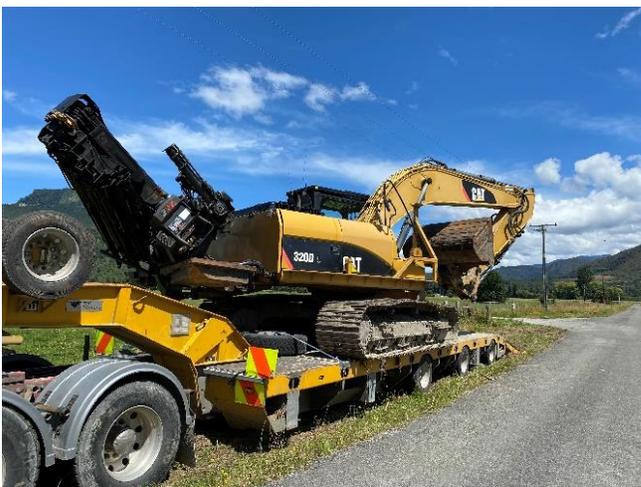
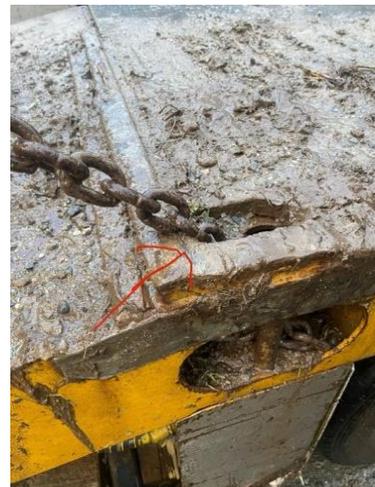
The worker was adjusting the chain in the 'keeper', on a lowbed transport trailer, when the Machine Operator, on the opposite side and slightly obscured by the trailer goose neck, operated the hydraulics to lower the trailer's loading ramps. The chains suddenly becoming tight and trapping the workers finger between the chain and the ramp resulting in an LTI due to the extent of the crush injury.

The area was made safe and first Aid provided and transported to an A&E for further assessment and treatment
