Event Number: 181162

WHAT HAPPENED

Safety Reminder

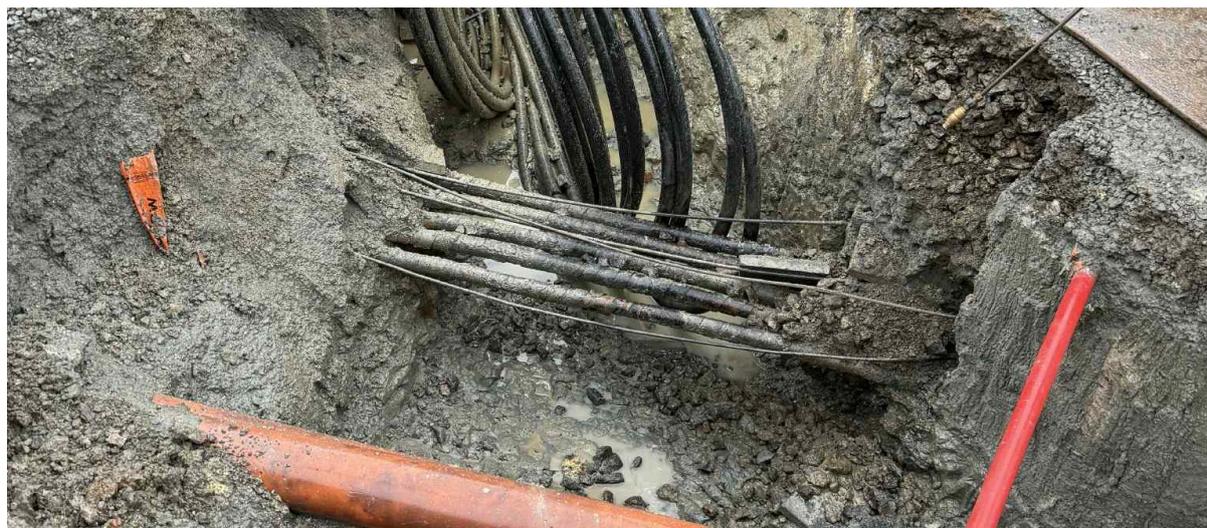
Workers were requested to work in and around exposed live HV PILC cables.

Work was suspended and the cables covered.

"Live paper insulated lead covered (PILC) cables, both HV and LV, and pressurised cables must not be handled under any circumstance"

"If other live cables or equipment are sited close to the cable or equipment that is being worked on, barriers should be used to separate them"
