# Electric Shock to a worker who contacted a broken HV dropper cable (SA573)

*High Potential Event / Critical Risk: Live Electricity*

Incident	Description	
<b>Event Date:</b> 27/10/2025	<b>Time:</b> 08:47 AM	<b>Location:</b> SH1, Himitangi, Manawatu-Whanganui
<b>Investigation Status:</b>	Ongoing	<b>NP Reference / External Reference:</b> OCC16052 / ID: 1456882

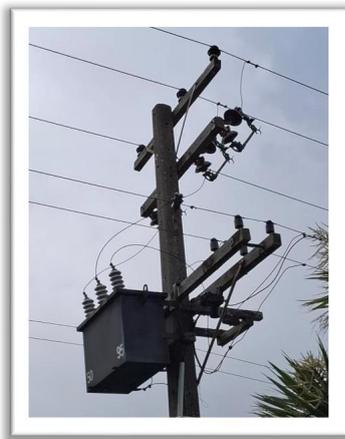
Image 1: Shows dropper cable loose. Image 2: Shows broken cable has come away from link

A Northpower worker attended a fault and, while testing low-voltage (LV) fuses, inadvertently contacted a high-voltage (HV) transformer dropper cable that had come away from the DDO and was lying across the LV arm, resulting in an electric shock.

- Pre-climb visual inspections
- Situational Awareness
- Lone worker protocols
- Robust training on hazard identification and application of direct controls
