FIRST ALERT

Hand Injury While Stripping Cable

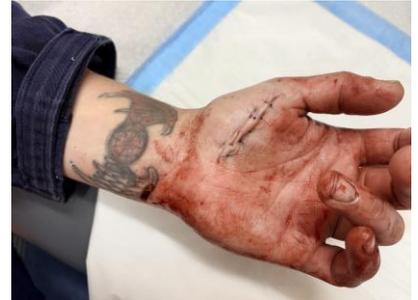
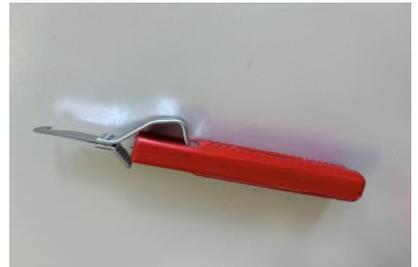
A low-voltage control cable was being terminated for a transformer oil pump. Due to heavy rain, the top end of the cable sheath became hard to pull open as it was wet and slippery. The worker removed their gloves to improve grip and get the sheath unstuck. The worker used the cutting edge of a Bizline cable stripping tool to separate the sheath tip. When pressure was applied the tool slipped, resulting in a deep laceration to the worker's hand which was holding the cable.

- The worker stopped work immediately and notified the supervisor of the injury.
- First aid was performed to control the bleeding and protect the wound.
- The person was taken to the nearest medical centre and received stitches.
- The task was paused to prevent further risk to others.
- The Incident was formally reported
- A safety briefing was held to remind the team of safe tool use and the need to stop work in adverse weather.
