Issued by: Health Safety and Training

Date: 20 May 2025

Issue: 2025 10

Inspecting your Dielectric Wellingtons

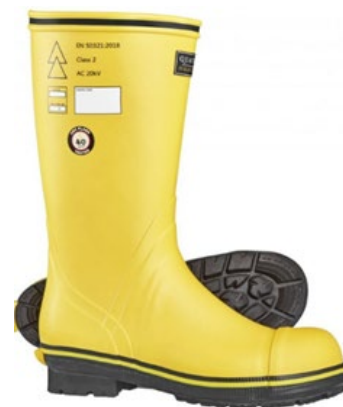
Sole wear

There is no wear indicator on the sole of the Skellerup Quatro wellington. Therefore, if you see damage on the flat sole area between the raised cleats, remove the boot from service as this can reduce dielectric protection. The Respirex boot has a yellow wear indicator. Check the sole for any signs of yellow or other damage, and remove from service if seen.

Remember that damaged footwear will not provide you with the necessary protection

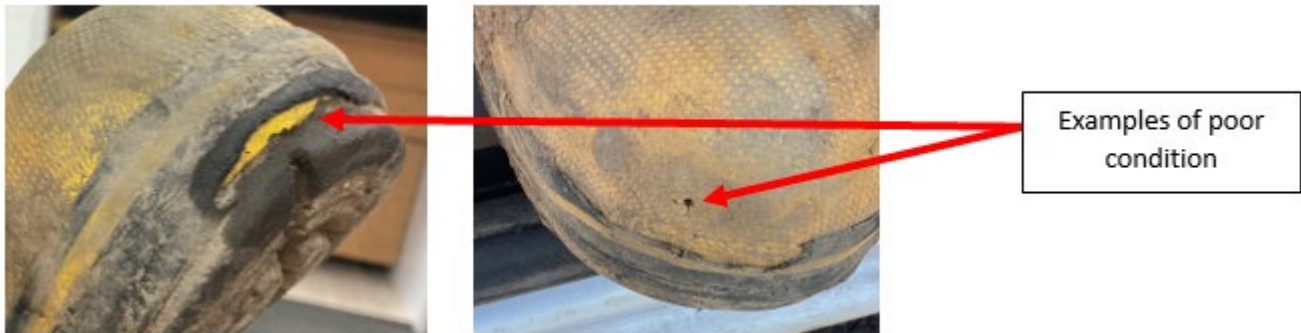
Outer condition

The outer part of the boot should be free from cuts, splitting, abrasions, holes, excessive wear, and delamination. If you find any of these, remove the boot from service as these can affect dielectric protection. This guidance applies to all dielectric wellingtons.

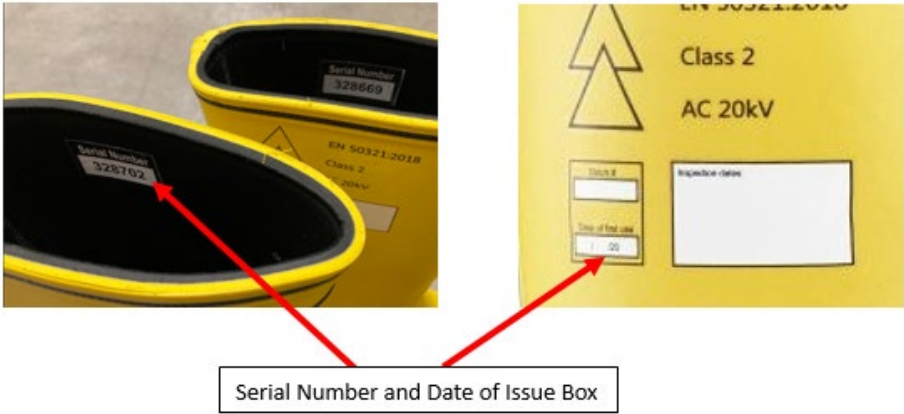
Serial number

Each boot has a unique serial number that can be found on the inside of the boot. This must be recorded along with the issue date.
