# Ratchet Dropped from Height Hits Worker on Elbow

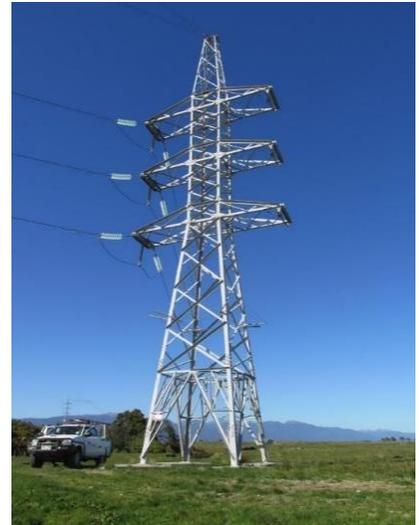
On 8<sup>th</sup> October 2020, while engaged in works to replace rusted tower step bolts, an ElectroNet worker was struck on the elbow by a ratchet dropped by a worker positioned further aloft on a transmission structure.

Initially the worker did not think that any injury had occurred, however swelling later developed on his elbow, along with pain. An x-ray was carried out and no fracture was found, however medical staff recommended resting the arm for a period of 1 week. The worker has since made a full return to work.

Workers were not considering the 3-dimensional aspect of an exclusion zone when positioning on towers. An exclusion zone should not be considered to be the area on the ground only.

Tool tethering had resulted in problems previously (which were unreported) and teams were not adhering to the requirements of TP HSW 01.02 Clause 3.11 which states 'Measures to prevent falling objects are to be in place, including tool and equipment tethering and the use of exclusion/drop zones below workers and when working aloft'. The use of lanyards was immediately re-instated. The suitability of tool tethering equipment is being reviewed and alternative equipment items may be introduced.
