People - Safety Incident Alert

Incident – Electric Shock

Date: 16 July 2020

Vault #: 8463

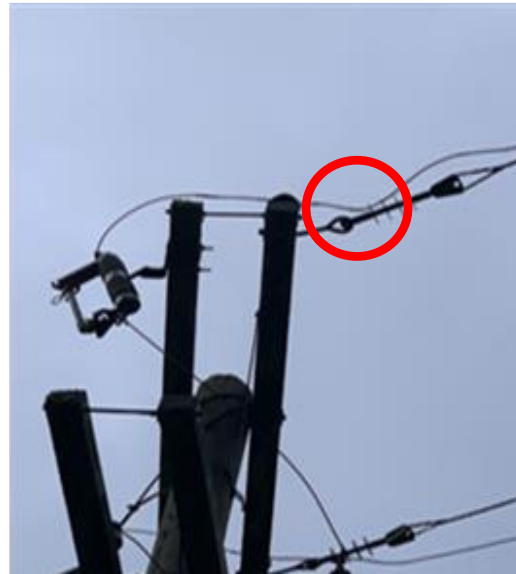
An Orion Network Operator (N/O) arrived at a worksite and proceeded to assess Low Voltage – reconnection work to be undertaken. He decided to isolate the work area, and this required two High Voltage (HV) 11kV transformer dropouts be opened that were feeding the (pole mounted) transformer at the site. The N/O reached his working position and commenced the isolation of the transformer, after this action the N/O made momentary contact with the upper section of the stay wire and experienced an irritation on his left-hand side cheek, it happened again a short time later, but this time it was felt as a minor shock. The N/O stopped work and had a closer inspection at the pole hardware above his working position and found that a HV jumper was in contact with an eye bolt.(see opposite)

Finding: There is a deflection on the HV jumper near the eye bolt (see above), the most plausible cause for this issue is impact by wildlife, e.g. birds or opossum/s, this interaction is the probable catalyst for the HV jumper being compressed downwards thereby making contact with the eye bolt. It is acknowledged that the N/O's view of the pole top and hardware e.g. jumper configuration during his initial risk assessment was restricted from the ground, hence the hazard of the jumper in contact with the eye bolt went unseen.

- Formal WorkSafe notification (online) of the event has been made by Orion
- A Safety Advice is to be developed and issued to the wider business for awareness and learning
- The configuration of the HV Jumper/s at the site have been rectified and no longer present a hazard
- Ensure that a Risk Assessment is thoroughly performed before work is commenced (Refer SM-EI / 3.303)
- Always review and confirm that your hazard controls, are fully effective (Refer SM-EI / 3.303)
- Ensure that PPE requirements are appropriate for the activity being undertaken (SM-EI Part 2 Section 13 – PPE)
