# SHEQ ALERT: LESSONS LEARNED

## Control the Load, Control the Risk

| DATE OF INCIDENT | 04/03/2026 | ALERT ID | AL-LL-133953 |

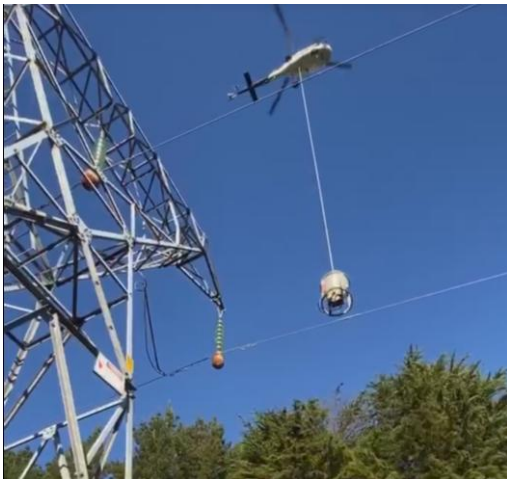
Helicopter carrying singular load

1. **Check your gear** — all lifting equipment must be inspected, calibrated, and confirmed serviceable before use.
2. **One load, one sling** — never share strops between loads to avoid shifting, imbalance, or release.
3. **Rig it right** — verify secure attachment, appropriate load rating, and correct configuration before lift-off.

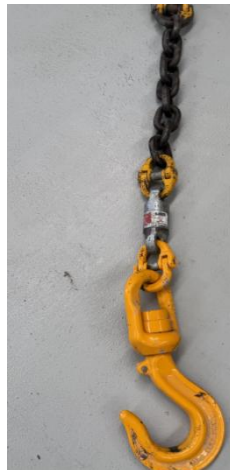
A helicopter was transporting a compressor and concrete skip as a combined load. During flight, the load shifted, breaking the safety catch and causing the concrete skip to detach. The skip fell into an uninhabited forest area. No injuries or property damage occurred.

Hook with missing safety catch

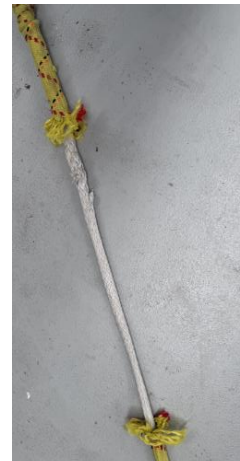
Missing sheath on lifting line
