## Electric Shock from Energised Secondary Circuit During Tap Changer Work

Date: 19/03/2026

Vault No. 6645

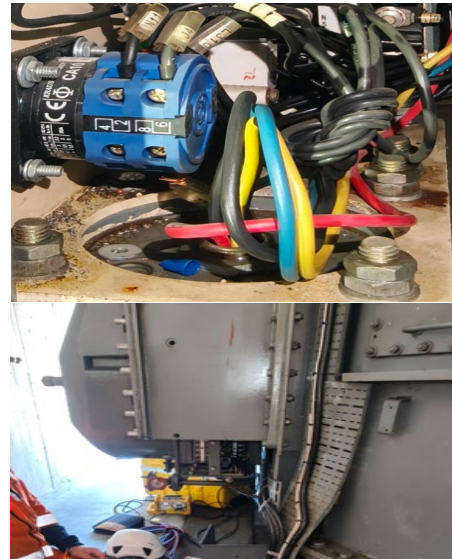
During maintenance work at a Zone Substation, a Site Supervisor received a 120V DC electric shock while assisting with reconnecting a loose control cable to a tap changer selection switch. Although the equipment was under an Access Permit, the control/secondary circuits remained energised. From the investigation: *“The Electrical Fitter was aware of the possibility of voltage still being present but was unable to communicate in a timely manner to the Site Supervisor.”*

- Reinforce Safe to Continue principles, especially when the task changes unexpectedly (e.g. loose cable connections, altered configuration).
- Treat all control/secondary circuits as energised until proven de-energised.
- Apply Prove – Test – Prove protocols before touching or manipulating any conductors.
- Maintain Minimum Approach Distance (MAD) at all times. The recorded tailgate identified MAD as a critical control that was not followed.
- Ensure clear communication between team members when hazards are identified, further supported by recording any secondary isolations on the recipient applied safety measures doc in conjunction with the authorization held.

- Testing terminals have now been installed to allow easy connection from the front of the control box. This will roll out to the other substations with this setup during upcoming planned outages.
- Review work methodologies when accessing control cabinets/enclosures and consider whether any further isolation of conductors is required?
