# Safety Alert

### AM-WAR-0018 – Work Advisory Restriction Notice – Softwood Pole Removal

## Work Advisory Restriction Notice (WARN) for Softwood Pole Removal

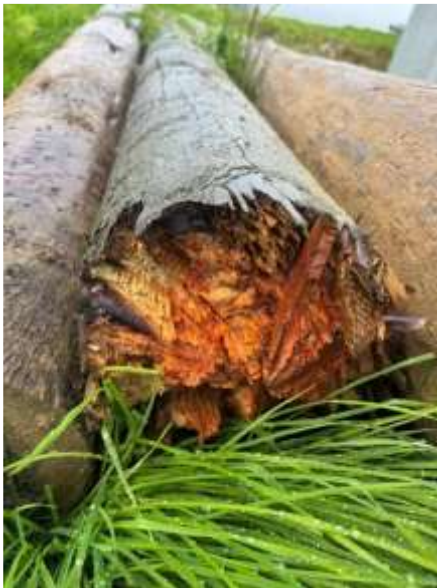
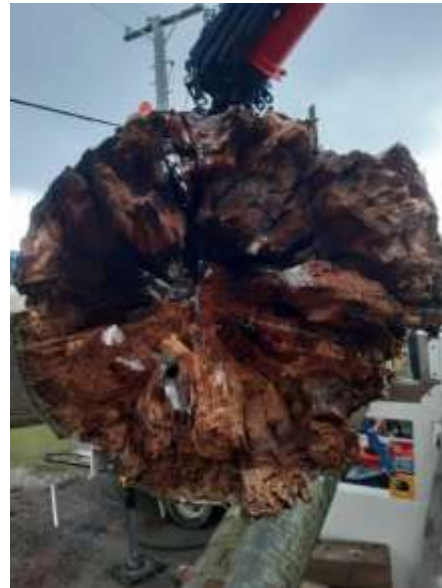
On 18 February 2026, a softwood pole failed during removal activities at Milton Prison Farm. The pole snapped approximately 2.5 metres above ground level during extraction activities. No injuries or equipment damage occurred; however, the incident had significant potential risk to personnel and plant.

This event is the second reported softwood pole failure within the past 12 months, first one was broken in the pole rack while being tied down when removing and the latest one failed at or near the first knot ring. Investigation and engineering review indicate that softwood poles can fail suddenly during removal due to changes in loading and stresses applied during extraction, particularly around knot ring locations.

In addition to that any work involving removal, extraction, transport, or handling of softwood poles shall adopt the following precautionary controls:

1. Prior to removal, complete a visual assessment of the pole condition, paying particular attention to:
  - Knot rings
  - Vertical splitting
  - Cracks
  - Signs of decay or damage
  - Previous tagging history
2. Where there is potential for load change or instability during removal, the pole shall be secured using secondary restraint methods such as:
  - Crane support

- Pole grabs
  - Chains or approved securing devices
3. Personnel shall remain clear of the potential fall or failure zone during extraction activities.
  4. Extra caution shall be exercised when removing poles with significant knot rings, particularly within 1.5 m to 3 m above ground level, as this has been identified as a common failure location in softwood poles.
  5. The preferred method for work at height on softwood poles remains the use of an MEWP where reasonably practicable.
  6. Any pole exhibiting abnormal movement, cracking, or structural instability during removal shall be treated as unsafe, and the activity reassessed before continuing.
  7. If any concerns exist regarding pole integrity or safe removal methodology, work shall stop and advice shall be sought from:
    - Field Manager
    - Asset Management / Engineering

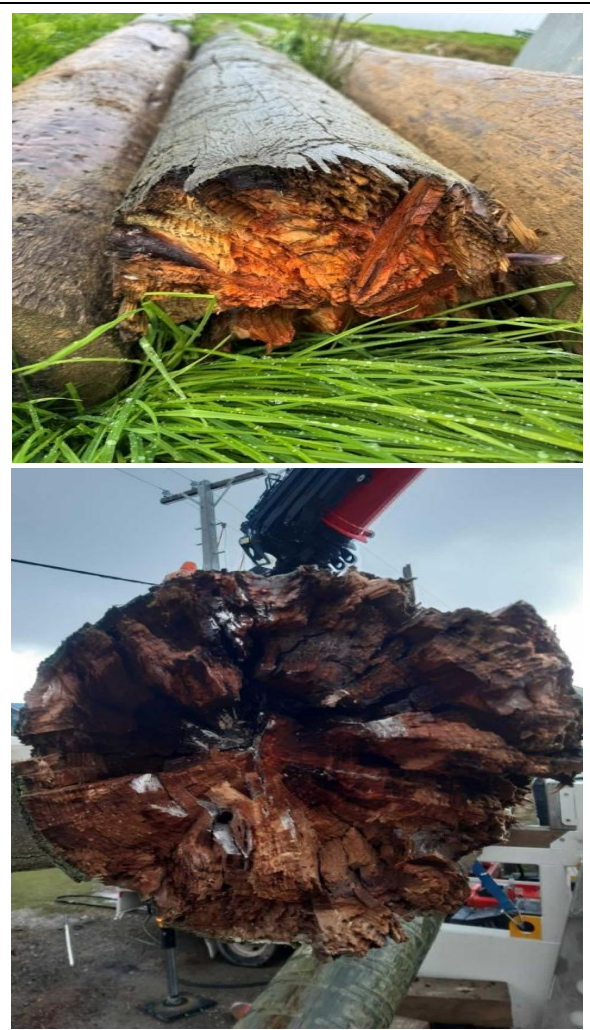
4. Extra caution shall be exercised when removing poles with significant knot rings, particularly within 1.5 m to 3 m above ground level, as this has been identified as a common failure location in softwood poles.

1. Prior to removal, complete a visual assessment of the pole condition, paying particular attention to:

- Knot rings
  - Vertical splitting
  - Cracks
  - Signs of decay or damage
  - Previous tagging history
2. Where there is potential for load change or instability during removal, the pole shall be secured using secondary restraint methods such as:

- Crane support
    - Pole grabs
    - Chains or approved securing devices
  3. Personnel shall remain clear of the potential fall or failure zone during extraction activities.

5. The preferred method for work at height on softwood poles remains the use of an MEWP where reasonably practicable.
  6. Any pole exhibiting abnormal movement, cracking, or structural instability during removal shall be treated as unsafe, and the activity reassessed before continuing.

7. If any concerns exist regarding pole integrity or safe removal methodology, work shall stop and advice shall be sought from:
    - Field Manager
    - Asset Management / Engineering
