## FUSE CARRIERS STORED AT HEIGHT

### OVERVIEW

During a period of bad weather in December 2025, a set of three PC400 pole mounted fuse carriers fell from an LV pole and struck a member of the public on the head.

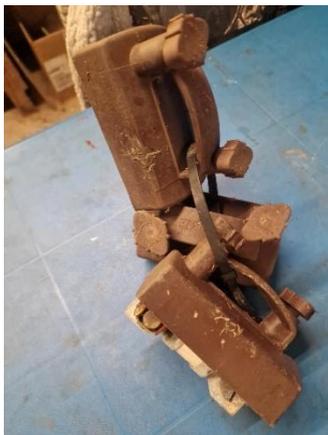
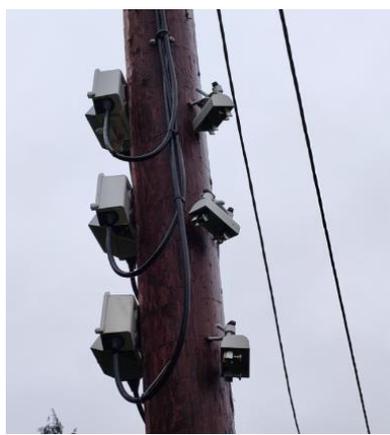
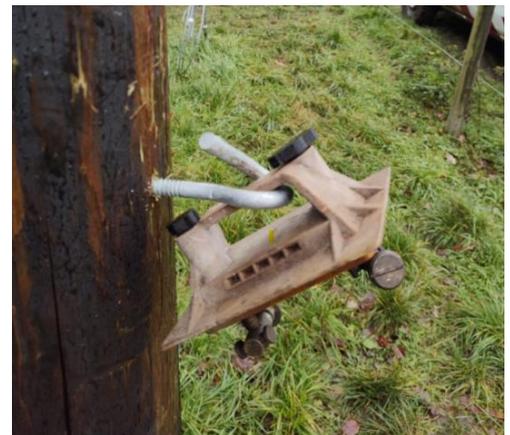
The fuse carriers had been secured using a cable tie which had weakened over time and broken.

Plastic cable ties are susceptible to deterioration and likely to fail after exposure to weather and UV light. They are designed to bunch cables into clusters and are not suitable to suspend loads.

- When securing spare fuse carriers or blanks at height, do not use cable ties.
- Where fuse carriers are found with cable ties as a method of securing, these shall be removed and replaced with a more secure method, using screw in pigtails
- Inspectors discovering cable ties being used to secure fuse carriers/blanks shall record this as a defect, so that these can be replaced.

Screw in pigtails have successfully been trialled at the Training School and can be ordered via logistics: - 13380G HOOK COACHSCREW PIGTAIL M10 ABC
