# SHE ALERT

## Finger injury caused by contact with a circular saw blade

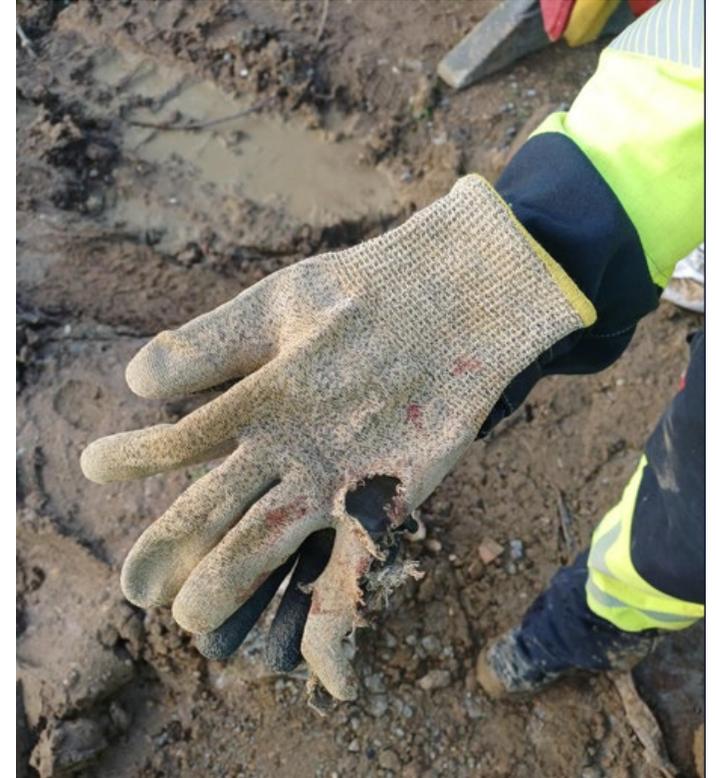
Date of incident	10/12/2025		Directorate	Distribution	
Region	Large Capital Delivery	Location	Cowley	Classification	Contractor Lost Time Injury
What happened ?					
<p>During formwork preparation for a concrete bund, a carpenter sustained a laceration to the left little finger when a circular saw kicked back while cutting timber. The wound was cleaned, closed with surgical glue &amp; stiches, with the carpenter requiring time off work to recover. The investigation has commenced.</p> <p><b>Immediate Actions Taken:</b></p> <ul style="list-style-type: none"><li>• All activities in the work area were halted immediately following the incident.</li><li>• The injured operative was taken directly to the nearest Accident &amp; Emergency department for assessment and treatment.</li></ul> <p><b>Key Risk control measures:</b></p> <ul style="list-style-type: none"><li>• Apply the principles of Plan-Scan-Adapt (<a href="#">watch the 2.5min video here</a>)</li><li>• Use both hands on two-handed power tools (e.g. circular saw).</li><li>• Secure the workpiece using clamps, a vice, or a workbench—never by hand or with assistance</li></ul>
