MEWP Overturns During Access to Field

The purpose of this Express is to serve as a reminder of good practice to be followed when accessing and egressing work locations.

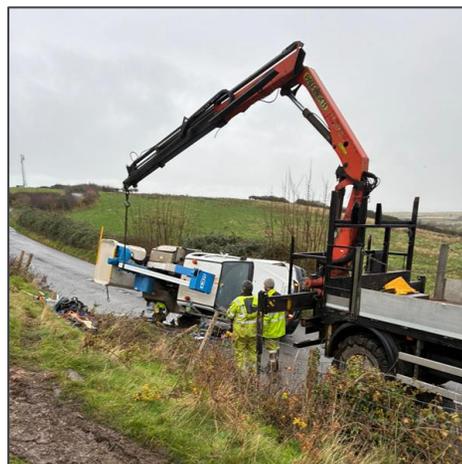
On Thursday 4th December at approximately 08:45, a contractor's MEWP slid down a grass track and rolled through a fence onto a busy road in Prestatyn, North Wales. The driver of the vehicle was taken to A&E as a precautionary measure, they were discharged later in the day, no injuries were sustained.

Overturned MEWP

- Safe access and egress to point of work must be considered during the project planning phase.
- Assess ground conditions, gradient and potential impact from adverse weather conditions.
- The risks associated with access & egress should be assessed and, where an unacceptable risk is identified, suitable controls should be put in place to ensure safety.

- Select appropriate vehicle, plant or equipment for the task and the environment it will be operating in.
- Ensure the vehicle, plant and equipment is maintained and certified as required.
- If the vehicle, plant or equipment is unsuitable for the proposed working environment, do not proceed, cease work until a safe system of work has been agreed.

- Must be a trained and competent driver/operator.
- Consider their experience with vehicle, plant or equipment and the environment they will be operating in.
- Off road driving training courses will improve competency of drivers who are required to operate vehicles on rough ground, away from normal roads.

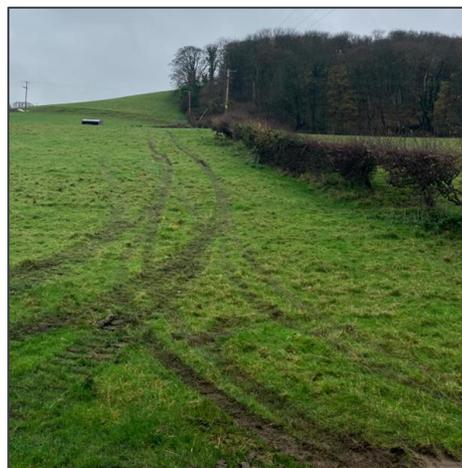
Incident Location
