Incident Alert

Vegetation worker injured during tree felling

Monday 14 March, 2016

Alert Number: 21032016

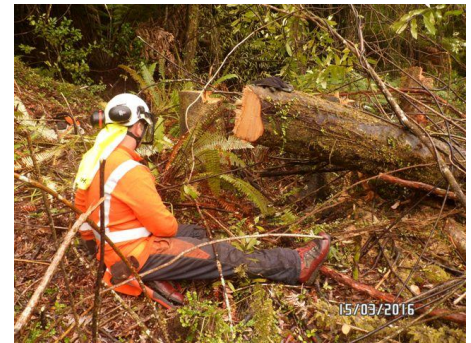
As a tree fell (as planned) a vine (which wasn't visible to the vegetation employee) pulled up and caught the operator, knocking him to the ground. He was struck on the side of the leg by the base of the felled tree.

Re-enactment of the position the injured worker fell.

- The vines were identified as a hazard on the Job Start and controls (such as cutting all visible vines before undertaking a fell) were in place. It is important to remember to maintain high awareness of your surroundings, especially when working in potentially unpredictable locations.
- The work-party was in constant communication with each other during felling operations which meant that the injured party received immediate assistance from his team mate.

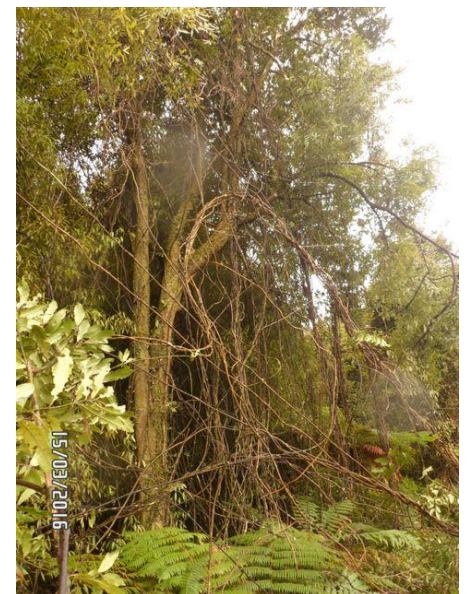
The worksite was in dense, native bush with vines entwined between trees, in the forest canopy and in vegetation on the forest floor.

Photograph showing the trees requiring felling

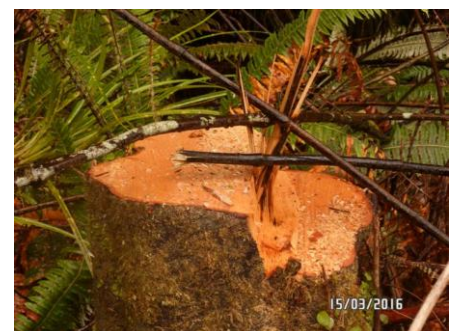
The base of the felled tree (which struck the worker).
