Incident Alert

Worker received an electric shock

Thursday 19 February 2014

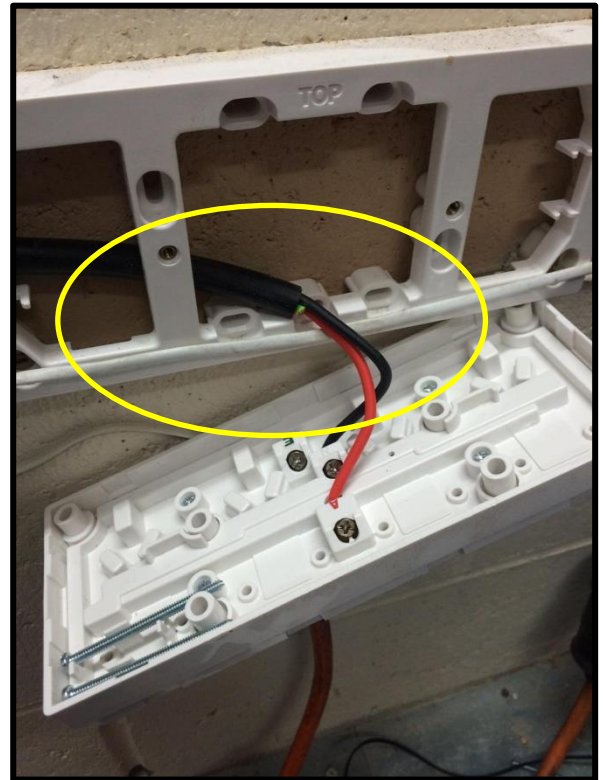
Worker received a minor shock due to an unearthed 230v socket at Takapu Road Sub-Station. This Socket was installed in 2012 as part of the Site Made Ready works (SMR) adjacent to the Desk Top Access Panel.

Be aware of the possibility additional sites may have unsafe installation. If found please ensure they are isolated immediately and reported.

Test all like installations prior to use.

Continue to use protective equipment such as RCD's when connecting to any supply.
