# FIRST ALERT

## Trailer Failure

**Location:** Reefton

**Incident:** Trailer detached from van when travelling at 90 kilometres per hour

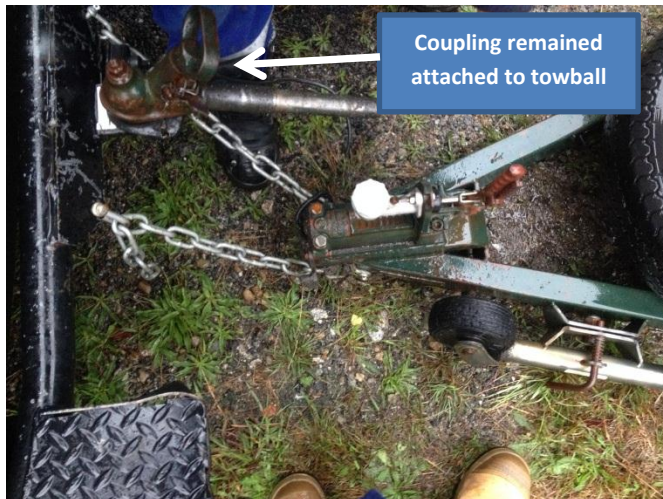
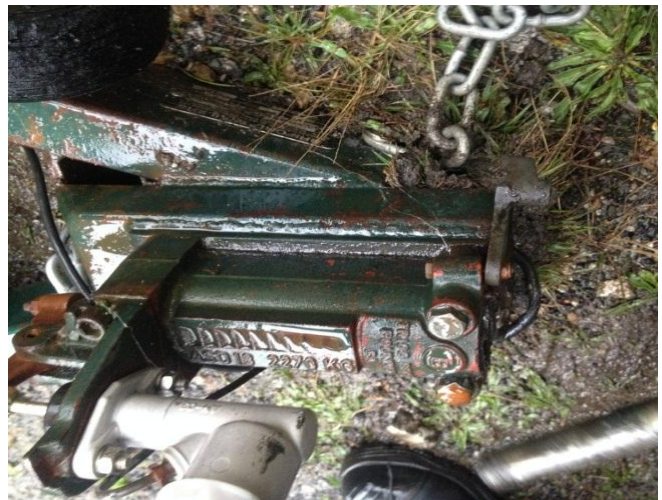
It was discovered that a permanent type split pin had fallen out and a sizeable nut on the back of the trailer brake system had worked its way off. This allowed the trailer coupling to stay attached to the towball, with the draw bar detaching.

- Mechanical assistance was sought from nearby Reefton and the trailer was repaired.
- The security and condition of this attachment point has been added to trailer check sheets.
