FIRST ALERT – SA251

Minor electric shock from live 230V cable

Date of issue: 03/12/2014

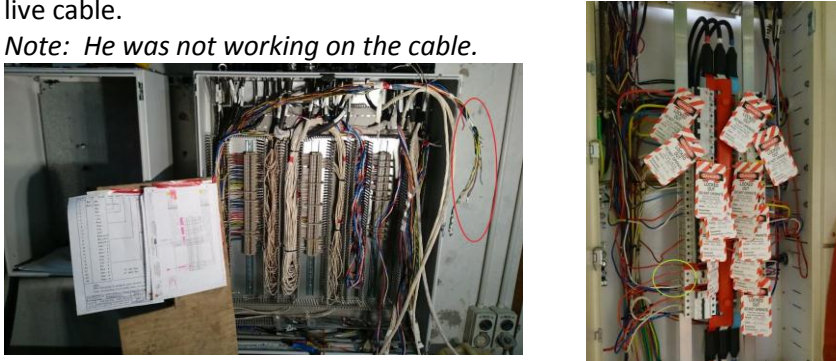
Incident	Description
<i>Date of Event</i>	27/11/2014
<i>Location</i>	Haywards Substation
<i>Time</i>	12:45
<i>Injuries/Damage sustained</i>	Minor Electric Shock
<i>Event Description</i>	<p>Employee was in the process of a job handover of the wiring and termination of a new panel which had existing cables that were to be re-used. When he leaned against the cabinet he came into contact with a live cable.</p> <p><i>Note: He was not working on the cable.</i></p>

<i>Initial Actions Taken</i>	<p>All work was stopped and the employee was taken to the local medical centre to be assessed where he was given the all clear to return to work. The work site was made safe and the offending cable was identified and isolated. The incident was reported to both the client and Northpower management with an investigation now underway.</p>
<i>Actions Required / Messages</i>	<p>It would appear at this time in the investigation that:</p> <ul style="list-style-type: none"> • The cable had been mistakenly connected into a breaker reserved for future works. • The Lock Out system that was used on the old MCB was not compatible with the newly installed MCB. Safety by design issue as other installations onsite may require review. • The worker was working in an environment that had been given an assurance of isolation.
