Safety Advice 44-2013 (Nov) (NZ)

E12626 Raw water used to top up the fine water cooling system on the HVDC Pole 3

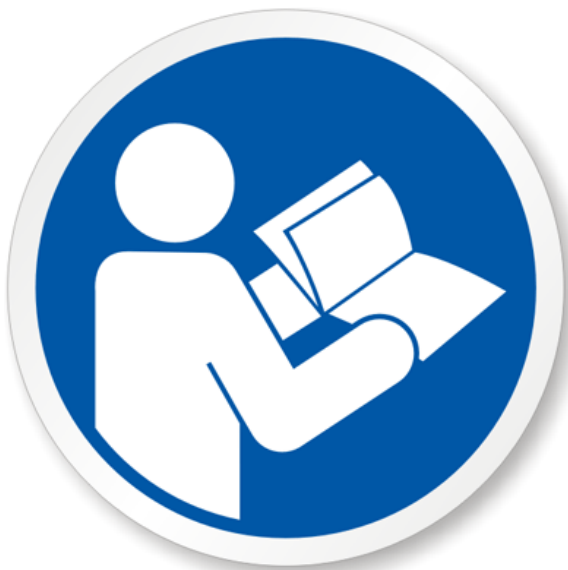
Raw (ionised) water was used to top up the fine (deionised) water system at Pole 3. The system circulates deionised cooling water around critical plant. It is crucial that deionised water is used as this is non conductive.

The mistake was identified prior to the ionised water being circulated, avoiding damage to the plant. The ionised water was removed and the system was topped up with the correct deionised water.

When there is no written procedure we must refer to the equipment manual.

If we are unfamiliar with the task and there is no information available stop the task and ask for assistance.

Prior to starting a task make sure that you have familiarised yourself with the procedure or manual.

If these resources are not available don't push on seek guidance from your Manager.
