Flashover during live LV jointing

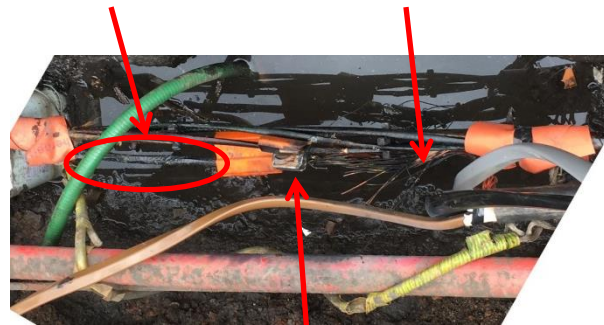
It was found that approved screening material had not been applied to the neutral/earth wires as required by [OPSAF-12-011](#) (LWM 4.1), part 11 step 3.

The jointer had applied insulation tape continuously along the length of the wires. This is not current practice as it prevents resin penetrating within the bunched wires. It is also not an effective screening material.

After the wires had been connected to the PILC neutral core, the setting of the brown waveform core in position in the L1 connector block caused movement of the cores of each cable, allowing contact to be made – with the connector either piercing the tape or touching a gap in the tape.

Breaching a 300mm² cable onto a 0.1in² cable is unusual and contributed to the incident due to the length and flexibility of the exposed PILC cores. The design had intended for the 300mm² to be breached onto a 0.2in² cable but due to communication breakdown the joint was completed at the wrong position. The use of screening material on neutral/earth wires is mandatory in all cases and would have eliminated the chance of a flashover.

Neutral/earth wires continuously covered in insulation tape

Approved screening material not applied to neutral/earth wires

Flashover between L1 connector and inadequately covered neutral/earth wires

Training centre example showing neutral/earth wires taped approx. every 100mm

- Approved screening material must always be used as required by the live working procedures. Refer to [OPSAF-12-024](#) (LWM 8.1) for details on the approved materials.
- Insulation tape shall not be relied upon for screening during live work procedures.
- The wires of waveform cables must not be taped along their full length. Taping approx. every 100mm is acceptable.
- When undertaking live work, always consider the effect of moving a conductor and what might occur as a result.
