## Condition and Risk Assessment of Substation Boundary Walls

### Risk of substation boundary wall integrity

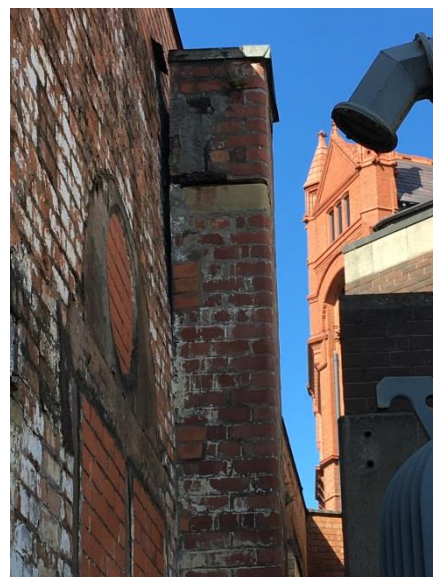
A substation inspector identified that a supporting pier and wall had become separated, the wall at this point is 8 metres high.

*Paradise Street – wall and support pier separated and steel degraded*

**It was established that there was no immediate risk, but a full structural assessment will be undertaken and repairs actioned.**

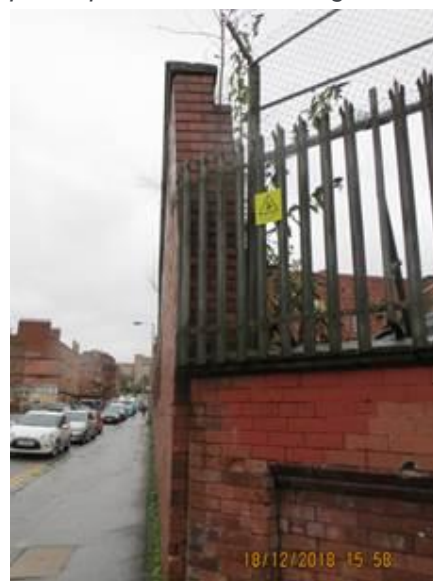
During inspections, a short section of the boundary wall was found to be **leaning onto a public footpath**. The area was **immediately cordoned off** by the District to **remove any potential risk to the public.**

*Top section leaning towards public footpath with vegetation growing through structure*

**Plans are now in place to repair the wall and demolish the defective section.**
