## Follows NSL Incident Notification IN NSL-1.5.1-SM1-IN-0005

## Title: Collapsed temporary scaffold

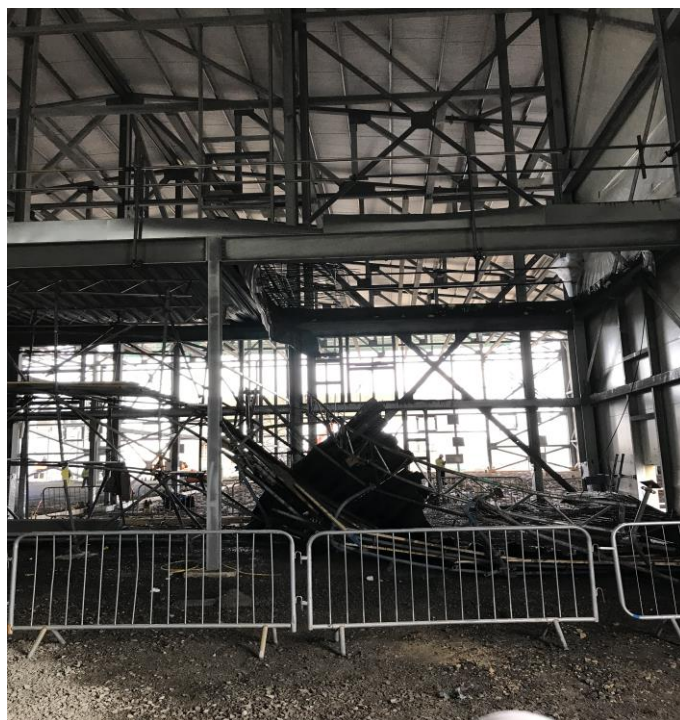
## Collapsed Scaffold photo:

At Blyth converter site on 10<sup>th</sup> April, a gang of 4 Malin operatives (sub –contractor to [REDACTED]) were working on the roof of the Plant Room within the DC Hall (Pole 2). As the gang were pouring and screeding concrete to create the fire rated roof slab, one of the operatives heard a suspicious noise coming from the temporary scaffold. The gang made the decision to evacuate the roof. At this point it was noticed that some of the steel elements of the temporary scaffold had started to buckle. ABB were notified and the area was closed off for investigation.

Approximately 1 hour after the after the gang evacuated the roof the scaffold failed and the section of roof where the concrete had been poured collapsed. No one was injured.

- Investigation carried out by ABB
- Appointed temporary works personnel did not enact their roles effectively
- Deficiencies found in the design process to ensure adequate design changes are effectively communicated and independently verified as fit for purpose
- Any loading calculations need to be checked and re-checked as fit for purpose prior to any use of the structure
- Design diagrams to construct scaffolding not sufficiently clear and not communicated to scaffolders effectively
- Ineffective relationships on site drove poor communication, cooperation and coordination of temporary works activities

- Ensure any temporary work design process is clear and understood by all with suitably competent and experienced appointed persons
- Ensure all parties involved are suitably coordinated, with effective collaboration and communication between them
- Ensure an effective assurance process to verify final designs to be built are fit for purpose and built to the design before any work is undertaken
- Create an environment where all involved in the temporary works are enabled to question instructions and stop work if unsure
