Issue No:	NB 193 v2.0	Issue Date:	11/06/2019
Type:	Operational		
Subject:	'Protection Blankets' installed in link boxes		
Applicable Areas:	All areas	Applicable Job Roles:	All Operational Staff involved in link box operations
Issued By:	Asset management	Author:	Tony Bond
Circulation: <input type="checkbox"/> All UK Power Networks Staff <input checked="" type="checkbox"/> Asset Management <input checked="" type="checkbox"/> Capital Programme & Procurement <input checked="" type="checkbox"/> Connections <input checked="" type="checkbox"/> Contractors <input type="checkbox"/> Customer Services <input type="checkbox"/> Finance <input checked="" type="checkbox"/> G81 External website <input type="checkbox"/> HR & Communications <input checked="" type="checkbox"/> ICPs (Independent Connection Providers) <input checked="" type="checkbox"/> IDNOs (Independent Distribution Network Operators) <input type="checkbox"/> Information Systems <input type="checkbox"/> Legal <input type="checkbox"/> Meter Operators		<input type="checkbox"/> Network Operations <input checked="" type="checkbox"/> EPN <input checked="" type="checkbox"/> LPN <input checked="" type="checkbox"/> SPN <input checked="" type

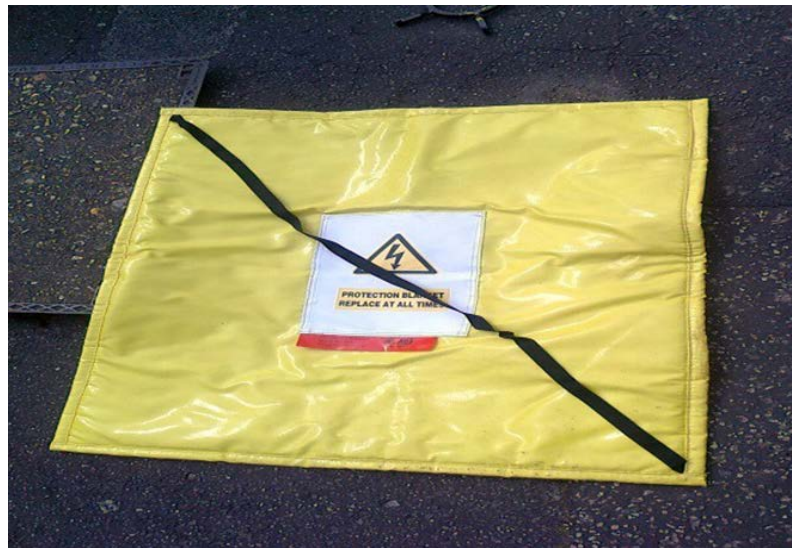
1. Lay the correct sized protection blanket over the link box pit with the label & strap facing up.

The protection blanket must be fitted neatly around the bell cover with particular attention being given to tucking it in around the edges. This is necessary to give maximum benefit in the event of a failure, as shown in the following four examples.

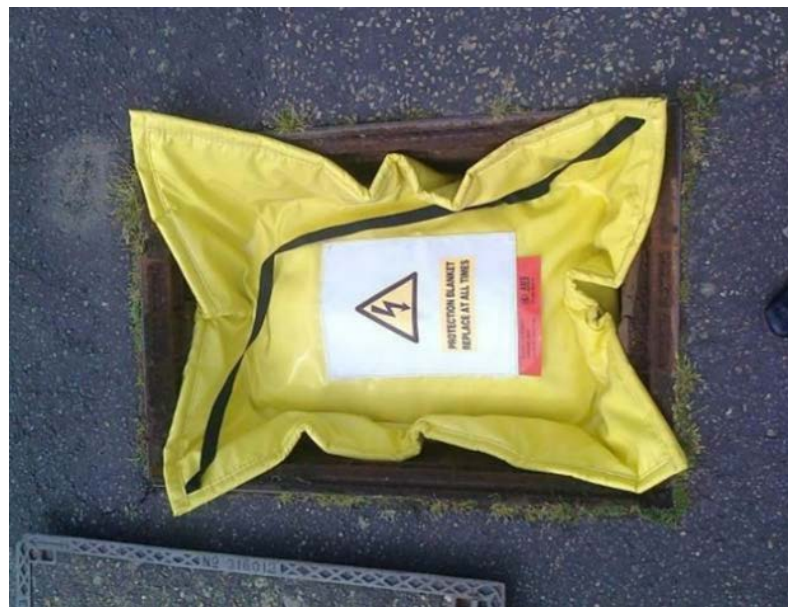
2. Push down on the label until it sits centrally over the bell cover.

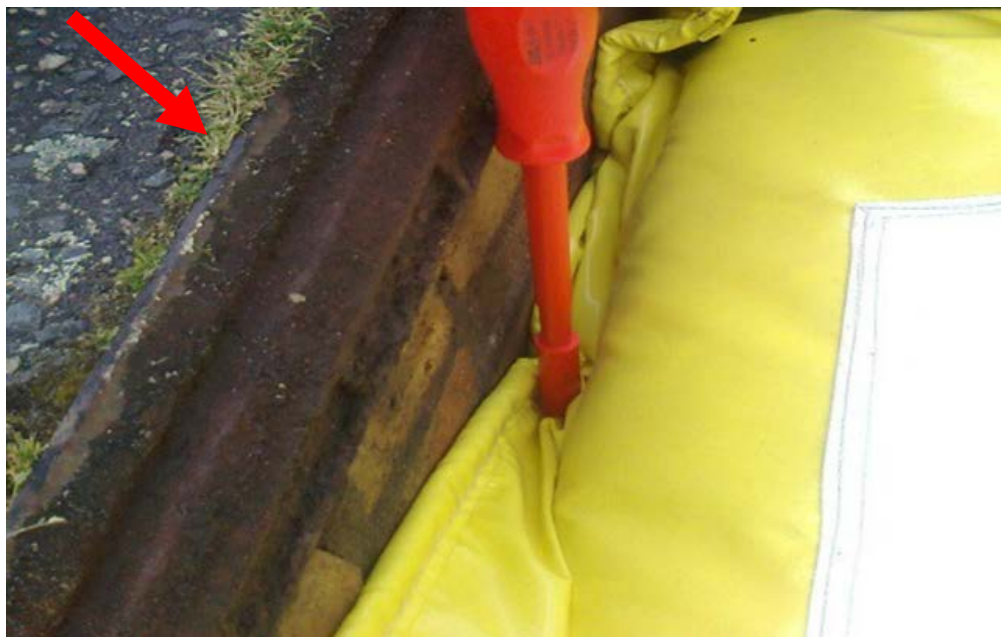
Female link extractor

3. Tuck the protection blanket down on all four sides of the bell cover using a suitable blunt insulated tool such as a Female link extractor.

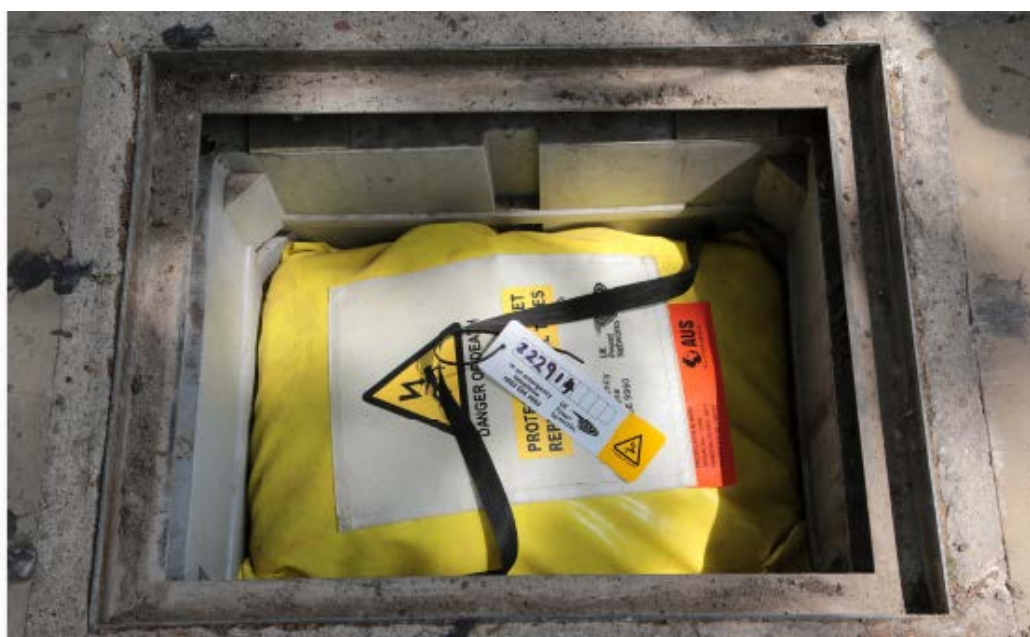
4. Protection Blanket in position tucked neatly around bell cover for maximum benefit

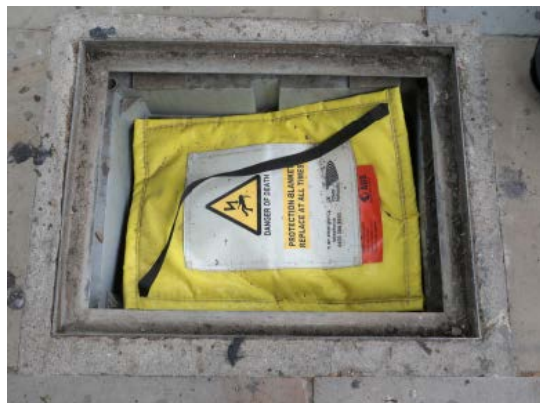
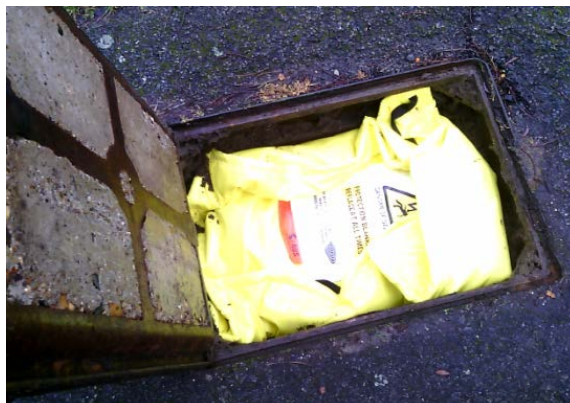
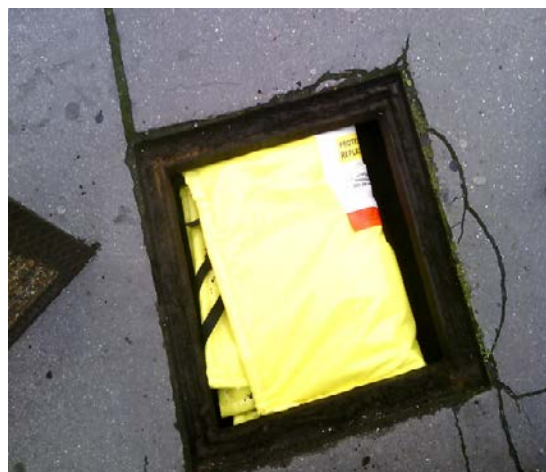
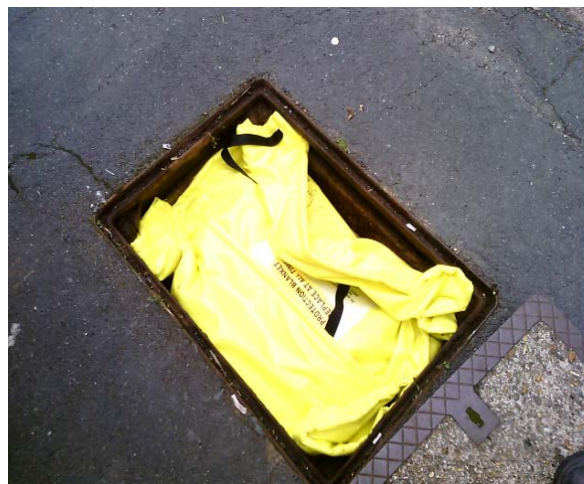
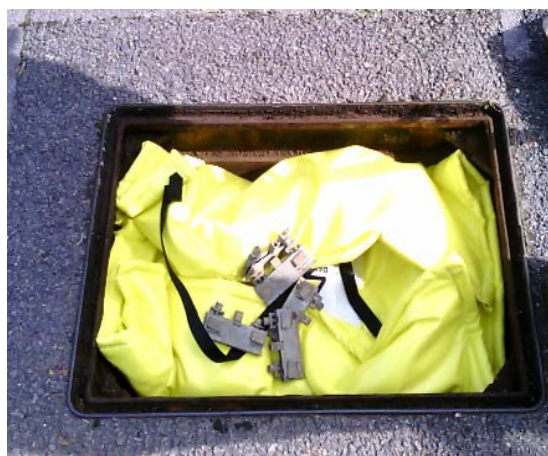
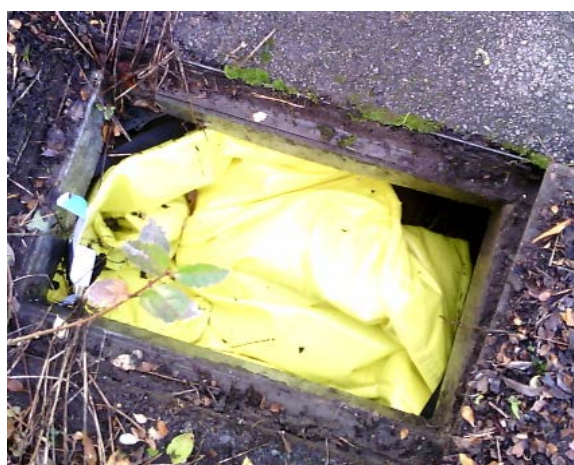
Examples of incorrectly fitted or wrong size protection blankets

This bulletin has been re-issued following recent link box audits, where the protection blankets were found to be incorrectly fitted or of an incorrect size.

It is essential that appropriate size blankets are correctly fitted to ensure they provide the required mitigation.
