## Young Child Falls into Excavation Adjacent Garden Pathway

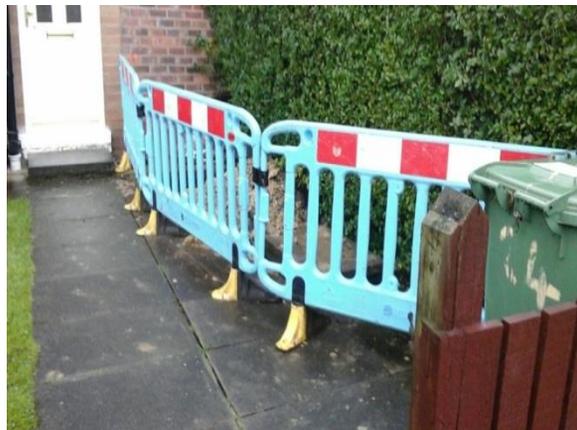
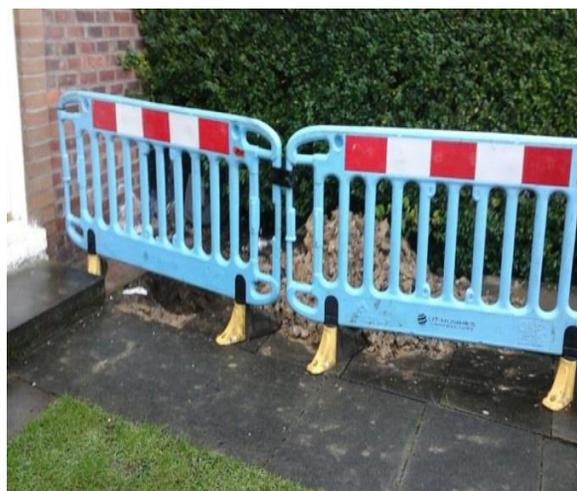
At around 6.30pm on Tuesday 21<sup>st</sup> November 2017 a young child (3 years old) whilst accessing the front door to the house fell from the door step and into a barriered excavation. The child sustained minor facial injuries which required medical treatment.

The excavation was required to allow the service cable to be cut to isolate the service position for the replacement of an obsolete service cut out.

The service cut out replacement had been completed on Friday 17<sup>th</sup> November and the excavation was awaiting reinstatement.

A barrier demarcation zone was in position and being checked daily with follow-up reinstatement scheduled within the contract SLA however this incident could have been avoided.

- Prior to excavation within a customer's property, discussion is required with homeowners to assess any risk the excavation location presents, along with the control measures needed to reduce/remove any hazards.
- Particular attention should be made to the access/egress to the property and to consider the potential risks, especially where there are known vulnerabilities, or young children who live or may visit the property. These requirements and the control measures should be recorded on the site specific risk assessment.
- Based on the above risk assessment, arrangements should be made to plan jointing and backfill on the same day.
- Walk boards should be installed over the excavation in addition to barriers for added protection around excavations in private gardens and properties.
