## Specification ENA TS 50-18 Issue 4

### Application of Ancillary Electrical Equipment.

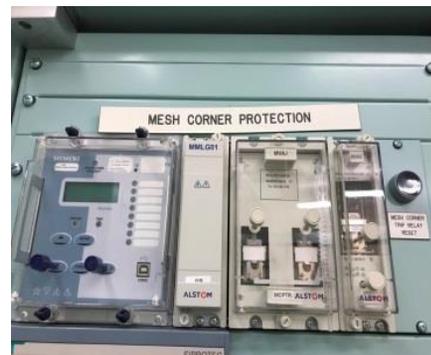
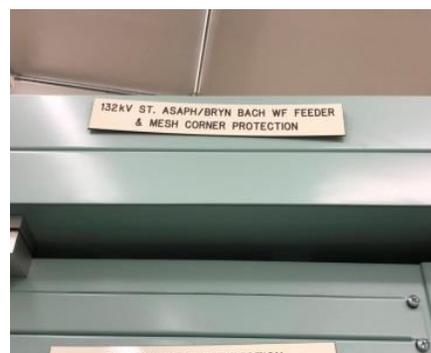
### Fuse and Link Labels

- The Clocaenog 132kV substation (North Wales Wind Farms project) received some Morson Projects control panels. Upon installation it was noticed that the identification labels were peeling away from the panel as they had been fixed with double sided sticky tape. Technical specification [ENA TS 50-18 Issue 4 Application of Ancillary Electrical Equipment part 6.8.b](#) states that, "Circuit identification labels, secured with screw fixings, shall be provided on the front of the enclosures and at the back where rear access is provided'.
- It was also noticed that on all the control panels the fuse and link labels do not line up with the appropriate fuse or link. This is due to the rails being fixed with pan head screws forcing the labels out of alignment and the labels being slightly oversized.

- If you receive any control panels on your project please check the condition of the panel identification labels and the fuse and link labels. These labels are very important and any missing or miss-aligned labels could result in incorrect operation of relays during the switching processes or wrong fuses and links being removed during the isolation processes.
- Defects must be reported in accordance with [OPSAF-04-021](#) Hazard Management Procedure. (For SPEN Projects defects must be reported using form I-PQM02UK-01 Rev 02 NCR-Defect Report which is located on ProjectWise.)
