SAFETY BULLETIN SB6/2018

LV Flashover when carrying out a live three phase cut out change

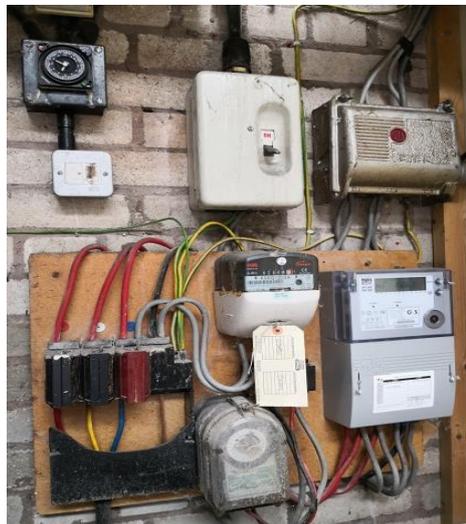
The base of the cut out had been reported as being broken and it was decided to change the whole unit. During this process there was a flashover. The cause of this is currently being investigated.

Service position prior to the cut out change commencing

- Staff are reminded that AFR clothing, approved dielectric footwear, electrical gloves and a full face visor **shall** be used at **all** times when changing a cut out live i.e. from when you initially assess it and remove the fuses to when you insert the fuses in the new one (ST:CA1C/8 p19 minimum PPE requirements for live jointing)
- Always check the condition of the cut out before deciding to change it using live techniques e.g. signs of overheating or damage
