33kV Cable & Accessories Feedback Workshop

Engineering Design and Standards (ED&S) hosted 33kV Cable and Accessories Feedback Workshops for the districts in SPM and SPD in September. The purpose of these workshops was to discuss the background to the recent high number of 33kV faults experienced by all districts this summer, the robustness and reliability of the 33kV jointing system we currently install, recent quality issues and to receive feedback of the cable and accessories that we currently use.

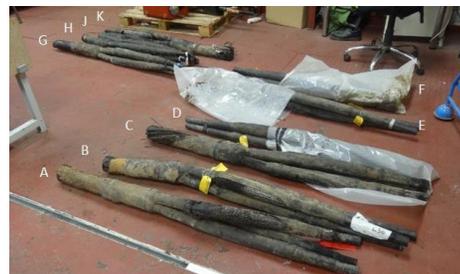
Faulted BICC Trif Joints

In summary, the rise in 33kV faults was caused by a manufacturing design defect in BICC cold shrink transition trifurcating joints (installed between 2002 – 2010) where a 3M cold shrink tubing component fails causing moisture ingress. A strategic replacement programme will commence in January 2019 to remove all affected BICC joints from our network (estimated SPM: 950, SPD: 1980). Logistics have increased monthly 33kV joint, resin and cable orders to ensure that stock levels shall be suffice for the replacement programme and/or should we experience a high fault rate again in 2019.

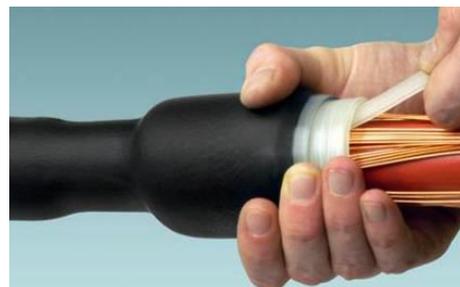
TE Connectivity Cold Shrink Joint Body

SP Energy Networks use an advanced cold shrink jointing system that has a design based on 132kV stress control technologies. ED&S have maintained a stance to continue with cold shrink technology owing to its proven reliability, aiding consistency in installation and reducing installation time. It also reduces the jointers exposure to heat shrink fumes and the use of open flames on site.
