Trailer Wheel Detachment

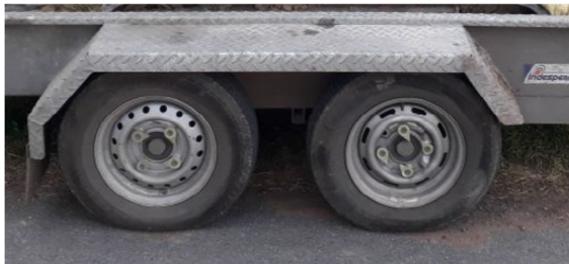
- b. The wheel-nut indicators were clearly not aligned on the day of the detachment from the photos taken, indicating some movement in the wheel nuts, but no action was taken.

3. The trailer contained two types of tyre rim, one of which was the factory fitted Starco rim and the other three being replacement AMW rims from Wheel Solutions Ltd. The replacement rims had significant wear on the inside and the conclusion of the experts is that the movement between the wheels and the brake hubs during use resulted in the wheel bolts coming loose.

Photograph showing different rims and wheelnut indicator configuration

- All trailers must be checked immediately to ensure that the wheel hubs on the trailers are compatible with the trailer. Where this is identified they must be quarantined or exchanged.
- All trailers in the business must have a 12 week inspection as a minimum, and this must be held by the central Supply Chain Team. This includes subcontractor trailers.
- All trailers must be tagged to show their next due 12 week inspection check.
- All daily checks must include photos of all wheels on the trailers on a daily basis.
- All wheel nut indicators used in the business must be set so that they are at point-to-point configuration so that it is obvious if they have moved during use.

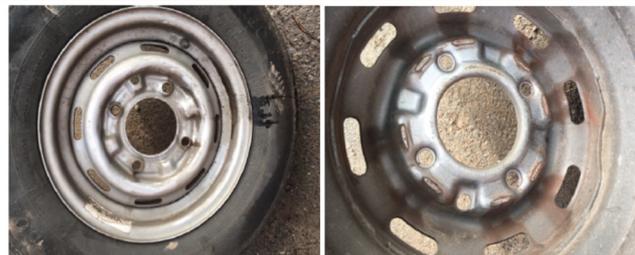
Replacement wheel rim supplied by Manufacturer

Inside of wheel rim (Clear evidence of wear spots)

Photograph showing replacement rim, which had significant wear on the inside
