SHE ALERT

Vehicle rolled away across main road whilst parked to close gate after egress from site

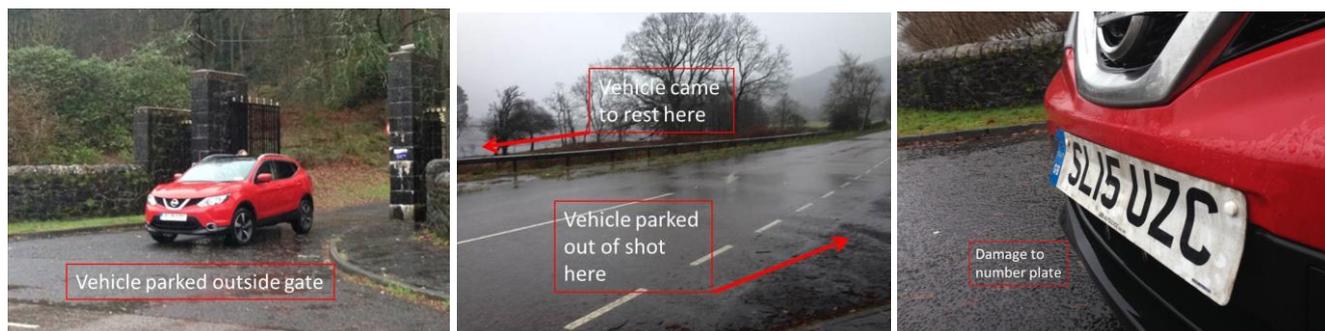
Company vehicle was parked outside main gate to Sloy power station whilst the driver locked the gate for the night. The vehicle was left with the engine running and the driver thought he had applied the handbrake. The unmanned vehicle rolled across the A82 coming to rest on the grass verge having impacted the crash barrier. Fortunately there were no injuries, no other vehicle was involved and, only superficial damage was caused to the vehicle which was driven from the scene. The potential outcome could have been impact with a fast moving third party vehicle, injuries and even fatalities.

At first glance the spot where the vehicle was parked appears fairly level but, there was still sufficient gradient for the vehicle to start moving.

- Set clear expectations with regard to the use of the H.I.T. (Handbrake on, In gear, Turn wheel to kerb) process and awareness of the hazards of run-away vehicles.

- Share learnings with your team and seek their opinions and feedback. Support, coach and involve team members in implementing safer behaviour. Refer to RS-SHE-112, Management of Road Risk and MA-SHE-112-001, Driver Safety Handbook.

- Be aware that a vehicle parked for a short time (e.g. when passing through a gate) is still parked and all normal procedures should be followed, i.e. turn off the engine and use H.I.T.
- Regularly check the operation of your vehicle’s handbrake.
- Vehicles can still roll away even where there is no obvious gradient.
